Upper Winooski River: Plainfield to Montpelier

River Corridor Management Plan

FINAL REPORT

MARCH 31, 2010

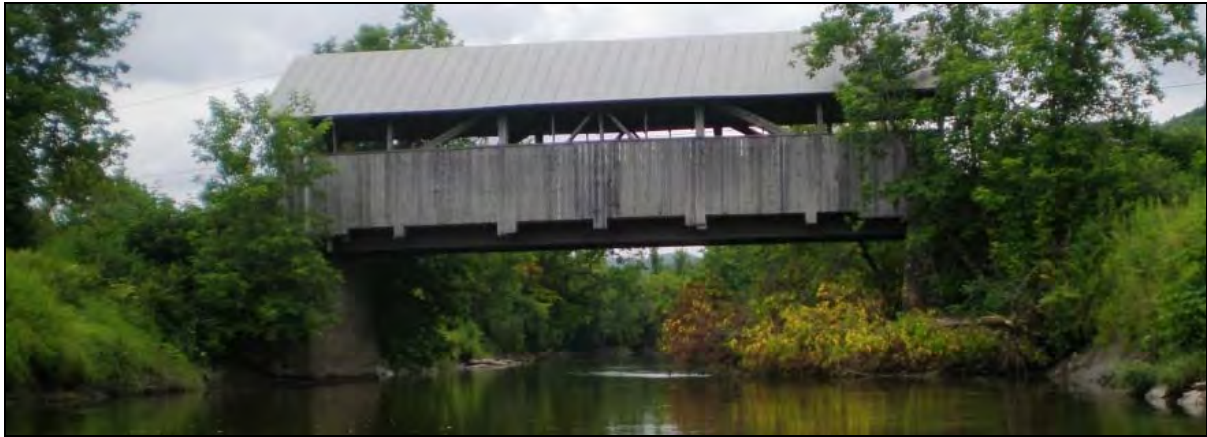
During the Phase 2 Assessment, several bridges and culverts were observed to be considerably narrower than the existing bankfull width, subsequently causing instability in the river (Table 3). In particular need of retrofit, based on the problems observed and their width as a percentage of bankfull width, are the Route 2 bridges spanning reaches R19, R22-A and R25, the railroad bridge at R19, and the Coburn Covered Bridge on R24 (Figure 12).

Figure 12: The Coburn Covered bridge (R24) was elevated to increase the area through which water can flow. Despite this, the bridge abutments still constrict the channel and upstream and downstream erosion is a result (see fallen tree on right bank).

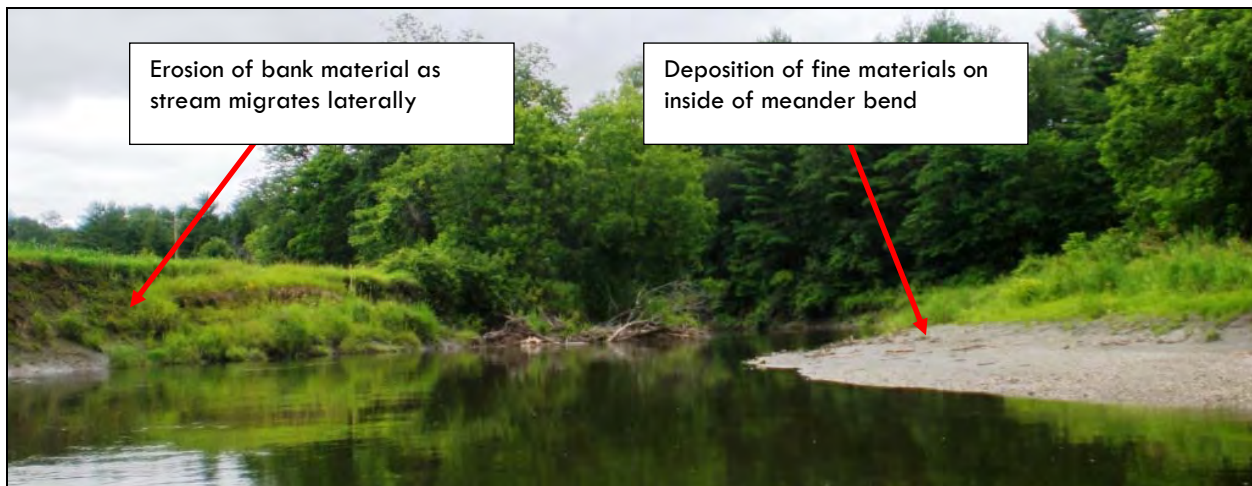
Figure 13: Planform migration as reaction to historic channel straightening (R23) of the Upper Winooski River.

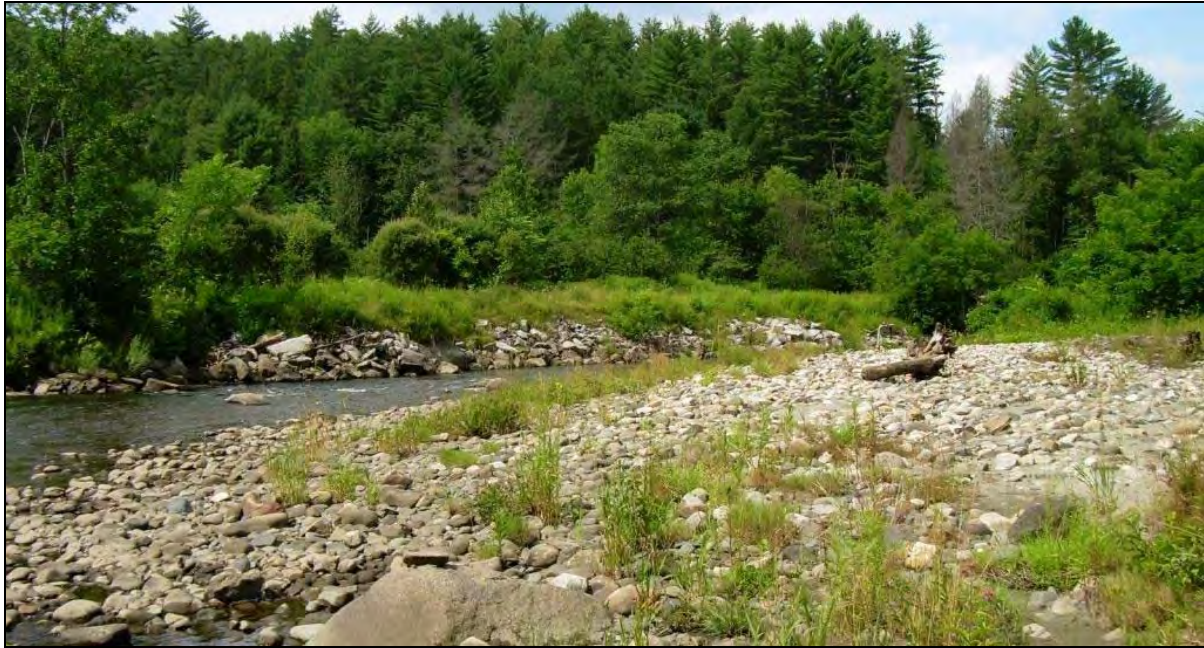
A road on the left bank has severed some potential floodplain access for the river. Riparian buffer removal on the left bank has also occurred in significant amounts. On the right bank some minor encroachment by residential development has occurred, however, overall the buffer is in better condition. The Plainfield Water Treatment facility, located within the river channel corridor is on the left bank next to the recreation fields. Future continued planform adjustment can be expected in this reach as the river works to develop accessible floodplain and to transport sediments arriving from Great Brook.

Figure 4: Dynamic channel movement in reach R26. New floodplain development and sediment deposition on inside bend (right), erosion and prevention (rip-rap) on left bank.

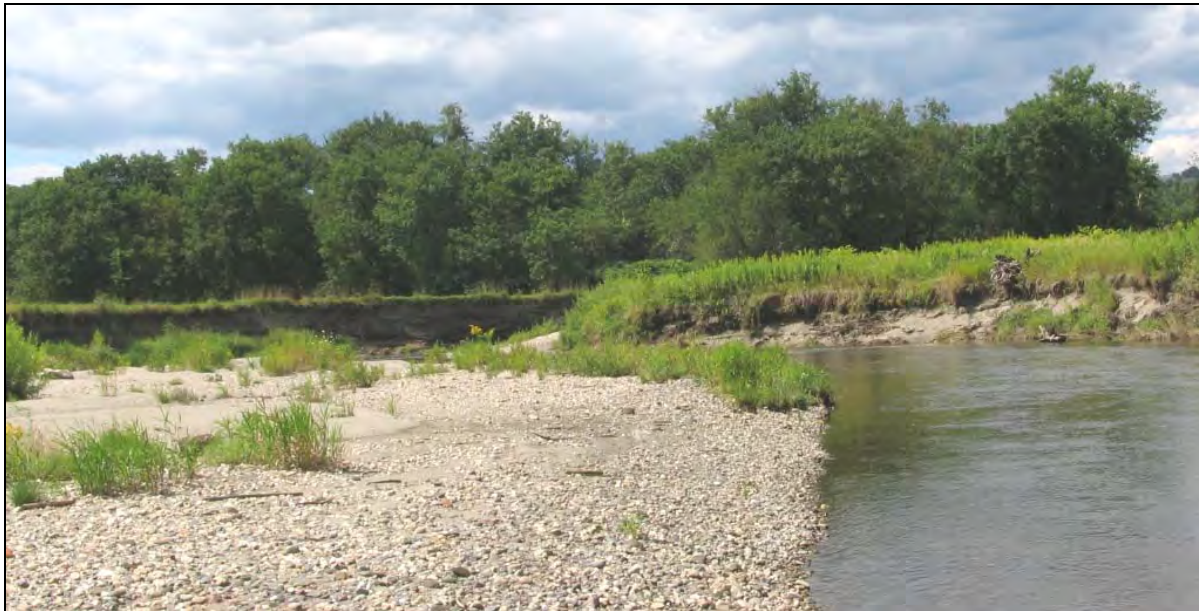
Figure 6: Widening and planform adjustment in Reach R25. Photo credit: Johnson Company

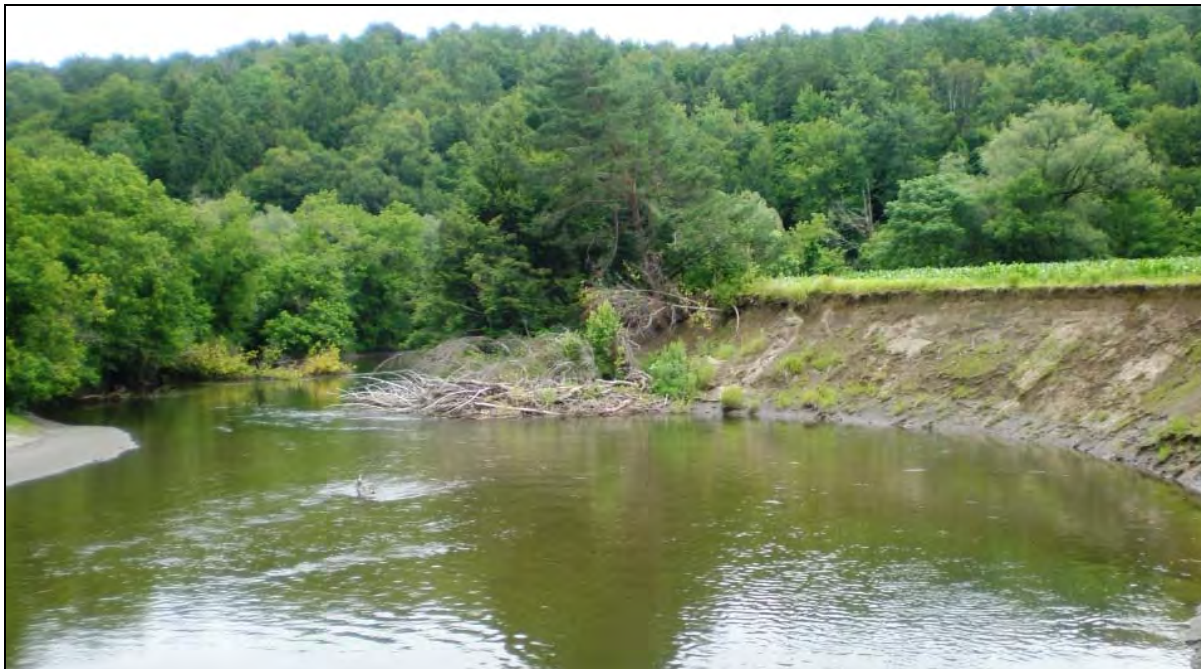
Figure 9: Significant streambank erosion through alluvial soils in reach R23.

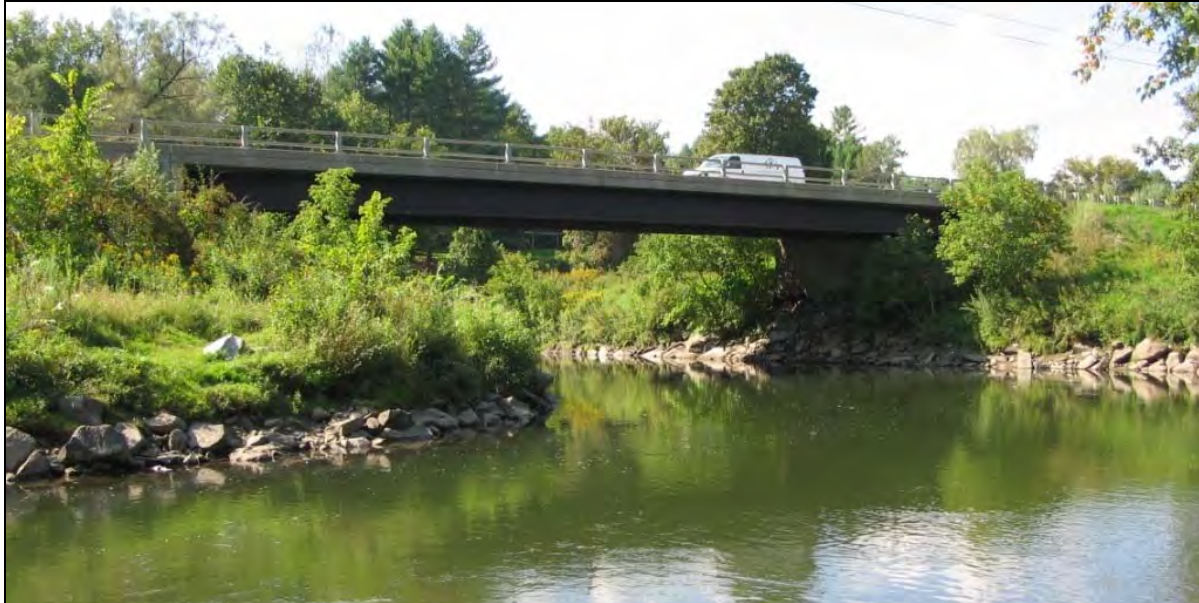
Figure 12: Route 2 Bridge with difficult alignment, R22-A. Photo credit: Johnson Company

Replace Undersized Structure	Open the river channel to allow for sediment transport, channel migration, and riparian habitat connectivity.	Replace highly undersized Route 2 bridge which is currently creating instability upstream.	Project will need to ensure protection of houses upstream and downstream.	High	Remains a bridge crossing, opens up for sediment transport.	Landowners VTRANS, Town, VTANR	High
	Restore Riparian Buffer	Long term channel stability, reduce flood velocities, nutrient uptake, habitat and other ecosystem services.	This is an incised and historically straightened reach. The left bank is predominately a road (Route 2), and the right bank has had significant riparian deforestation. Efforts to improve the riparian forest on the right bank may help improve instream channel condition and habitat along this reach. As well as provide long term ecosystem services for the community.	Few major structures along reach. River stability is good overall which will allow trees to grow.	Low	Pasture land to forest. Productivity shift to other economic, ecologic, and social gains.	Landowners FWR, WNRCD, FWS	Low

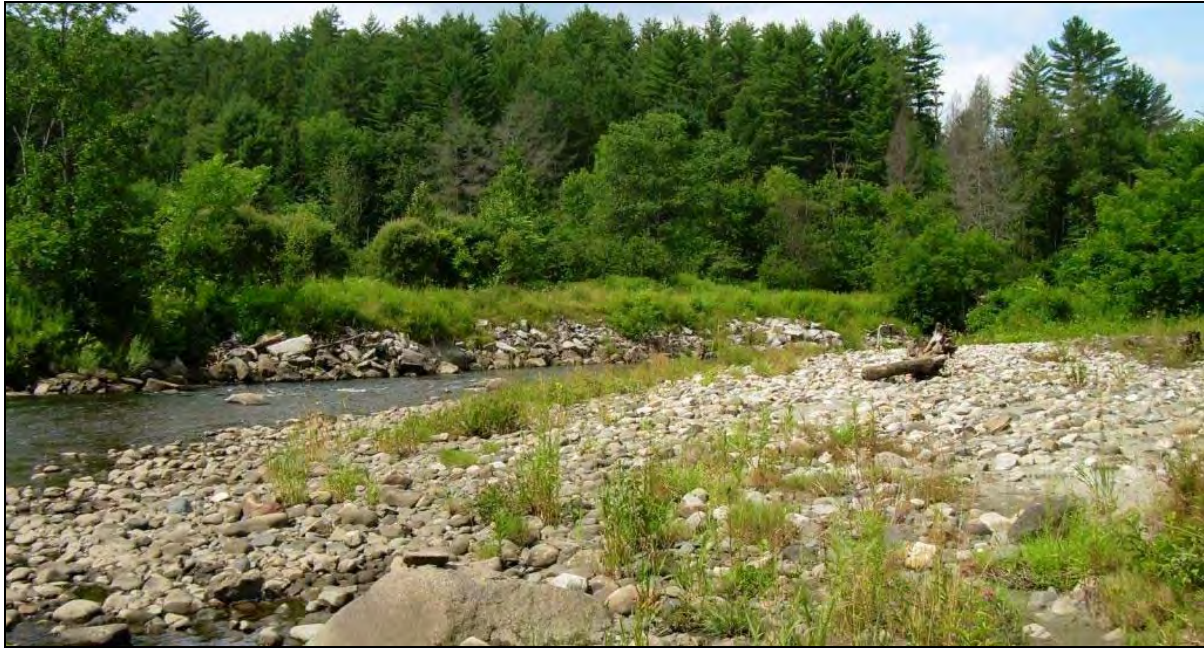
Figure 4: Dynamic channel movement in reach R26. New floodplain development and sediment deposition on inside bend (right), erosion and prevention (rip-rap) on left bank.

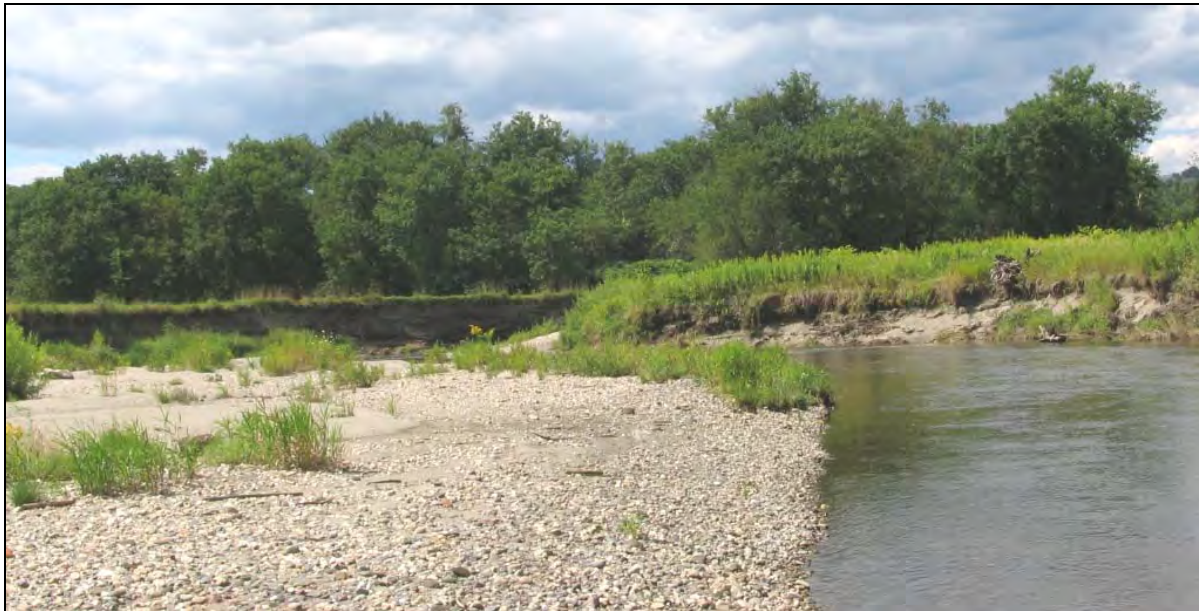
Figure 6: Widening and planform adjustment in Reach R25. Photo credit: Johnson Company

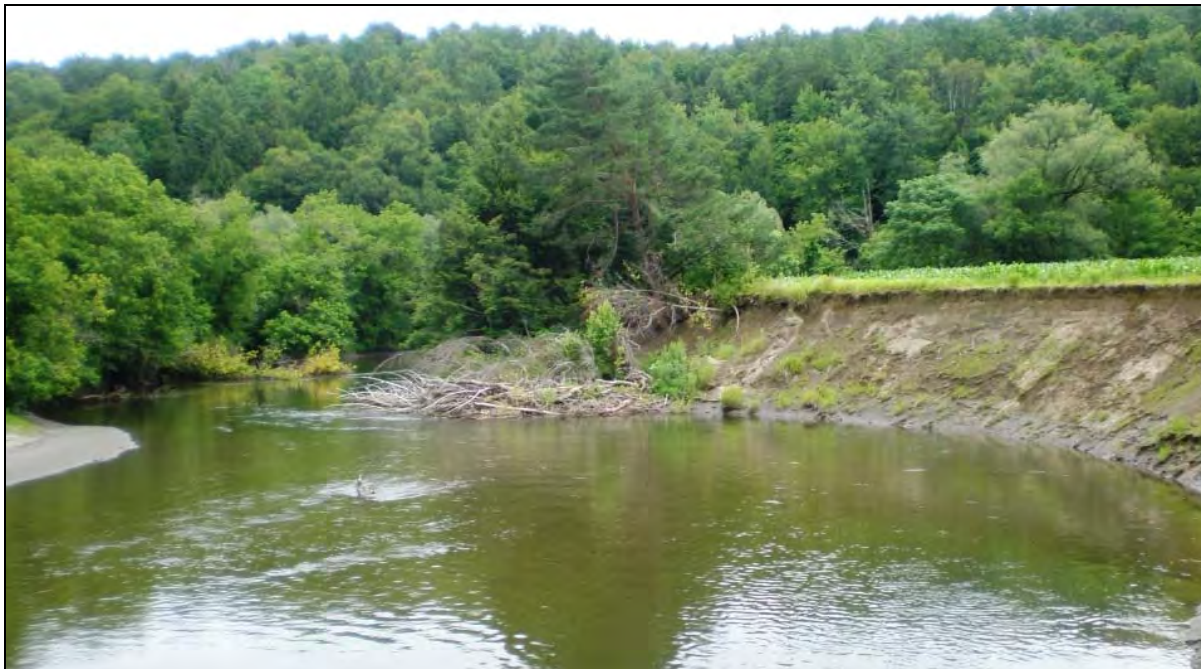
Figure 9: Significant streambank erosion through alluvial soils in reach R23.

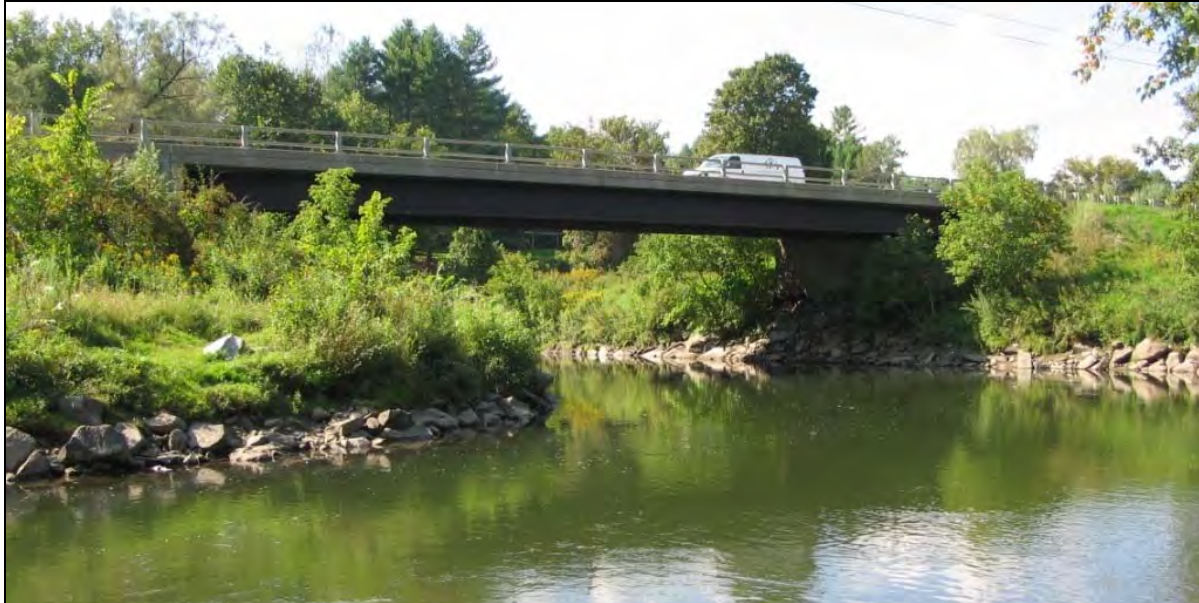
Figure 12: Route 2 Bridge with difficult alignment, R22-A. Photo credit: Johnson Company
