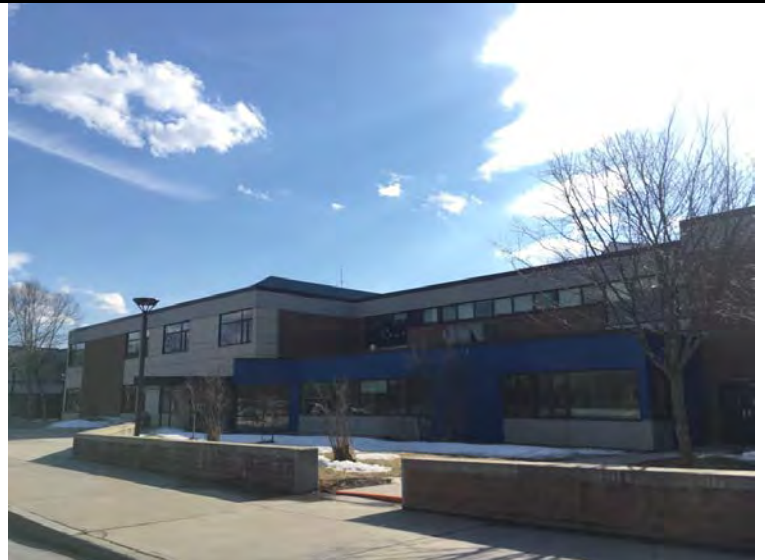
**Site photo**

Improve swale by track with sand filter; improve swale to west of school similarly; alternatively, install gravel wetland or sand filters to mitigate drainage by track; add check dams in lower extent of swale by garden planters; install a cistern for the adjacent roof drain for water reuse in the greenhouse and gardens by lower outfall on western side of property.

High school and associated parking lot and driveways

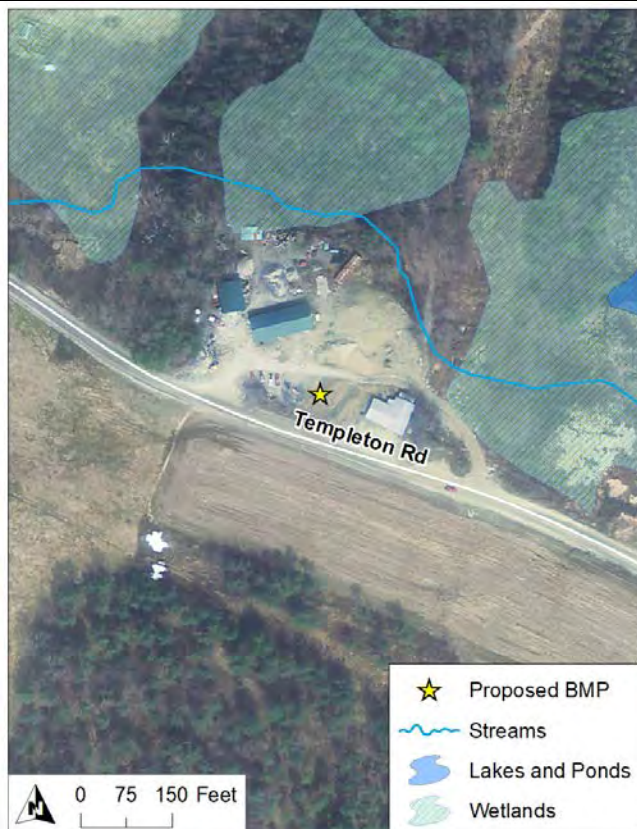
**Site map**

Town Garage with the Fire Station.

**Proposed BMP type:** Cistern / Rain Barrel, Ditch / Swale Improvements, Gravel Wetland or Sand Filter, Salt Management

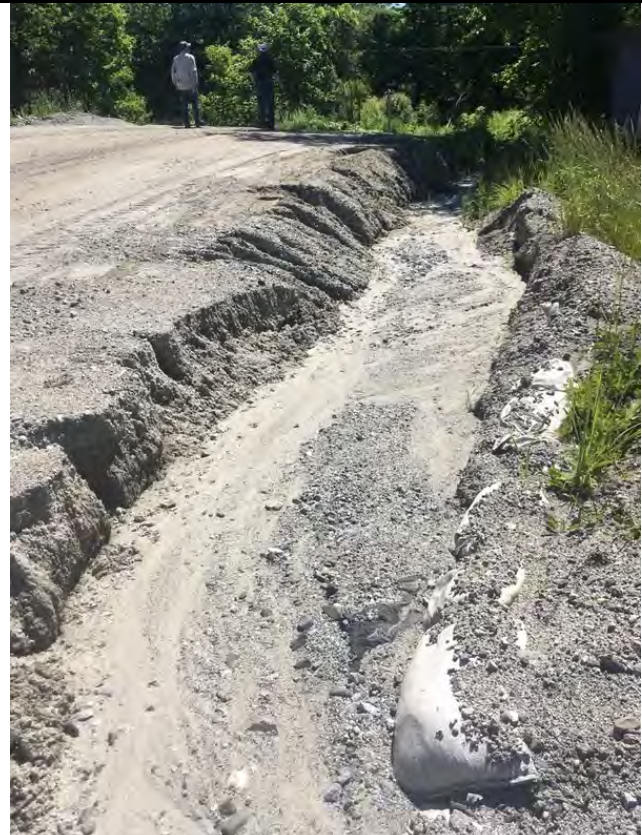
**Site photo**

Improve salt management to reduce transport outside of shed area; gutter roof and direct to a cistern for water reuse; regrade parking area and driveways and resurface (e.g. Staymat) to reduce sediment transport; line swales with stone; direct swales to a gravel wetland or sand filter located southeast of the site (outside of mapped wetland); improve sand pile management with a covered structure or retaining wall (this is proposed by town already).

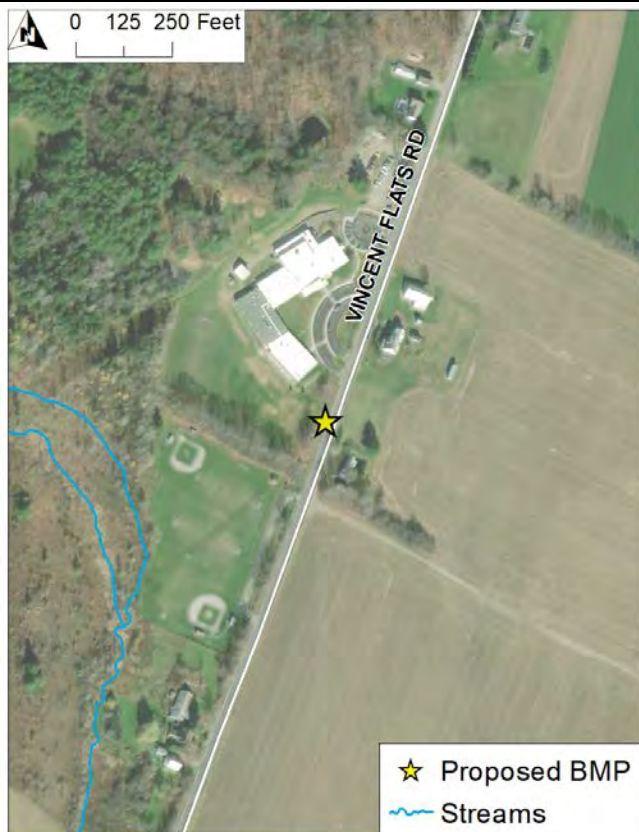
**Site map**

School site has a grass swale draining to a level spreader; stormline outlets to a wetland beyond the Town rec fields

Stone line the swale behind school to stabilize bank erosion; stabilize eroded channel next to walkway from upper parking lot; gutter roof of building in upper parking lot and direct downspouts to rain barrels (School's garden adjacent); amend existing swales in front of School to provide for more infiltration and redirect stormline flowing south from School to catchbasin by rec fields along the road for infiltration; revegetate area between grass and paved turn around in front of School (potential for curbing to prevent parking in this area). Note that a project is proposed for the adjacent rec fields.

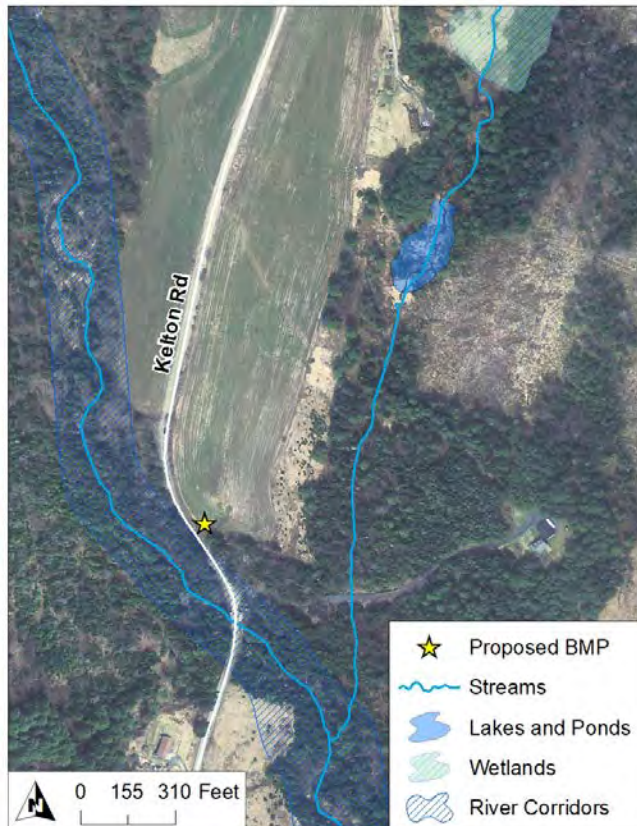
**Site map**

Farm field along Kelton Rd; drains south to stream.

Add basin to manage water draining from the farm field at the corner of the field near the road. If landowner is not participatory, a series of steps pools could be installed in the ditch area. Ditches should be formalized on the west side of the road with check dams and turnouts. Significant erosion noted.

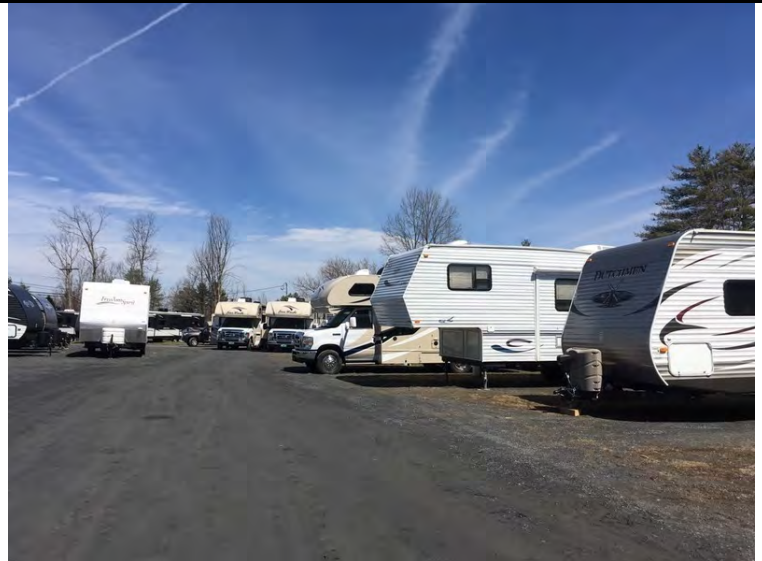
**Site photo**

Mekkelsen RV Sales & Rentals

Potential for a sand filter along road to the southwest of main site; add filter swale around perimeter of parking lot south of Route 2; direct roof drainage to cistern for water re-use for RV washing; potential to add hydrodynamic separator to prior to outfall southeast of main site; prevent soap from washing from entering catchbasins.

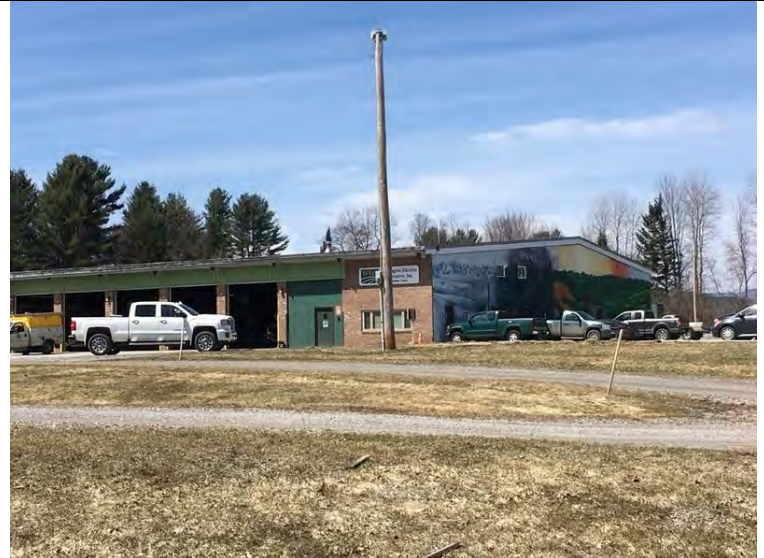
**Site photo**

Part of Packard Rd industrial park.

The western side of this site is managed via ponds. Potential for infiltration basins at outfall and at culvert inlet prior to crossing under road (currently area is a "ponding area"); there is also potential to reroute all drainage to basin in front of building prior to culvert inlet

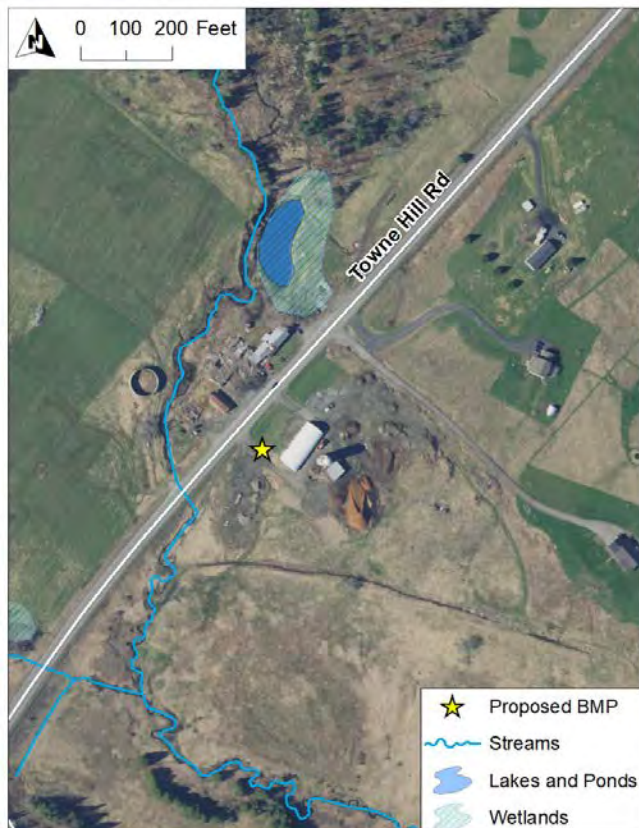
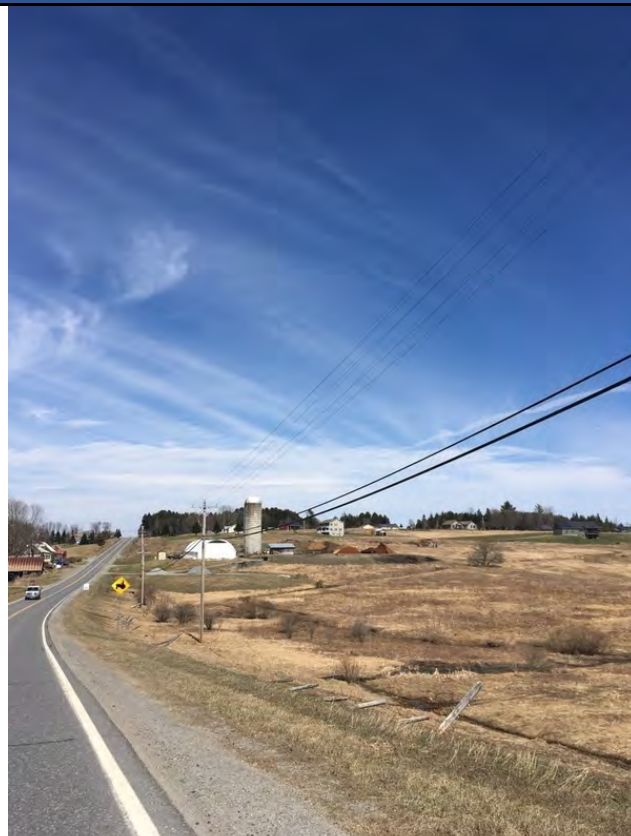
Materials storage site.

Implement a stream buffer along this whole area; gutter roof and direct to cisterns for water reuse if useful for operations; direct stormwater that runs along the road to a sand filter near the south end of site before stream.

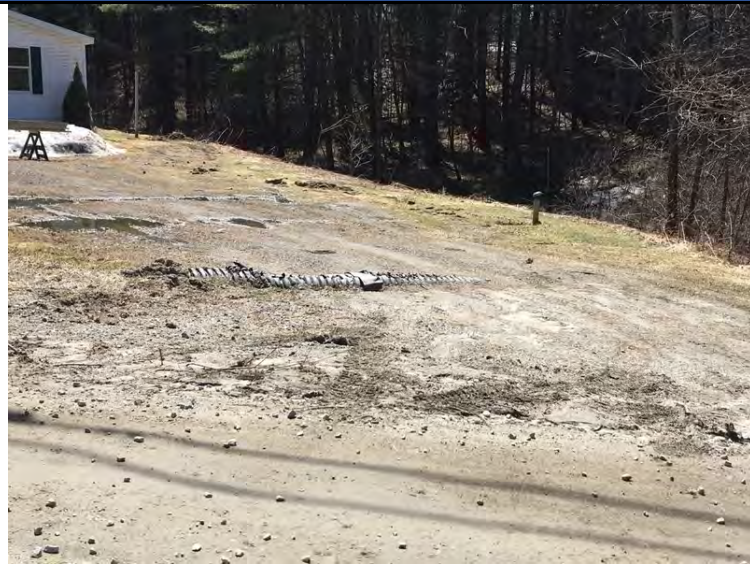
**Site photo**

Construct infiltration trench in existing swales; remove grader berms; add ditching or infiltration swale where possible; driveway culvert should be repaired (see photos); plant stream buffer along residential property east of stream crossing.

Road and surrounding development

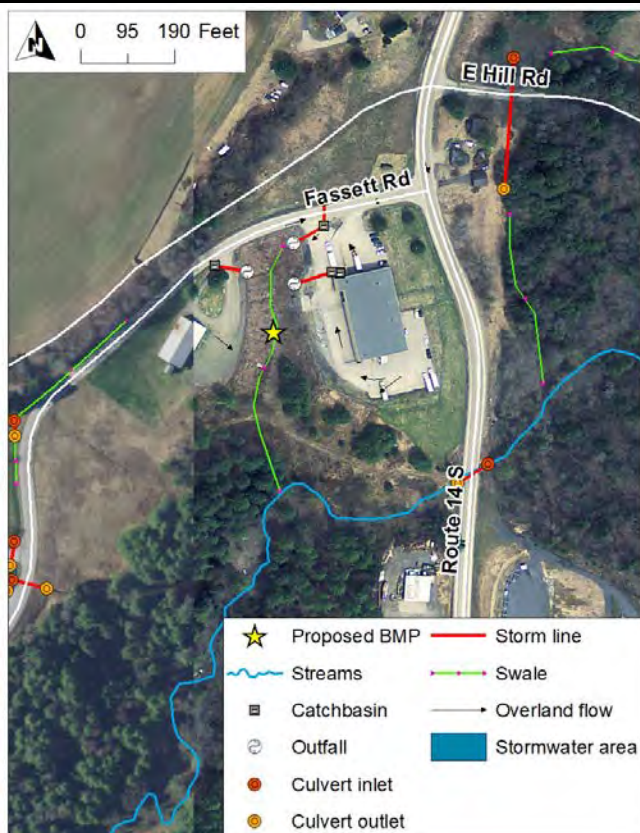
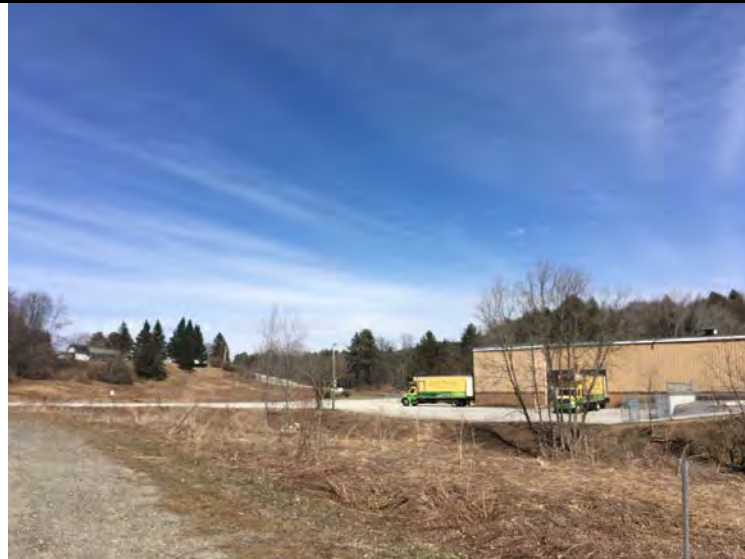
Church on west side of swale and Pine State Trading on the east side of swale.

Formalize basin feature in ditch to allow for infiltration.

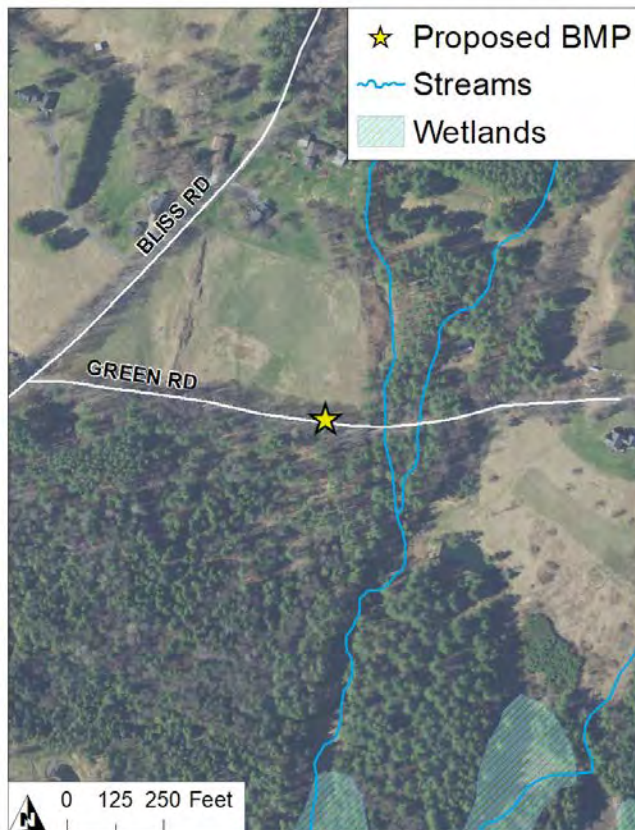
**Site map**

Area is very steep and there is an undersized culvert.

Road needs to be re-graded to better direct water off of road. Ditches need to be formalized. Stabilize existing ditches. Add check dams and turnouts where feasible. Eliminate grader berms. Logging activity was noted by stream. Add sediment trap before stream. Ditch is currently draining directly to stream. Erosion noted. Stream area is eroding. Stabilize. Add buffer.

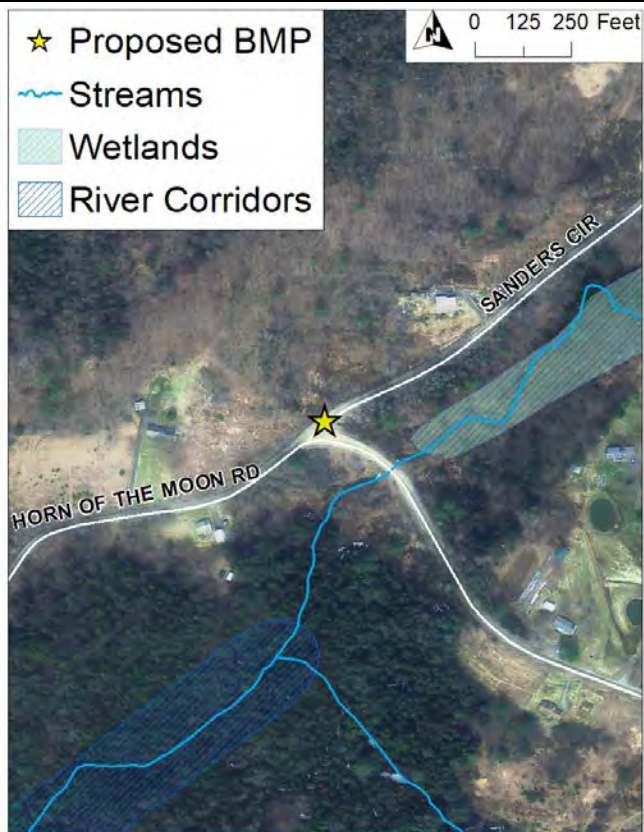
**Site map**

Intersection is overly wide. Large triangle area could be revegetated and a practice to detain road drainage implemented. Ditches should be stabilized and check dams and turnouts added where feasible.

Road intersection with noted issues.

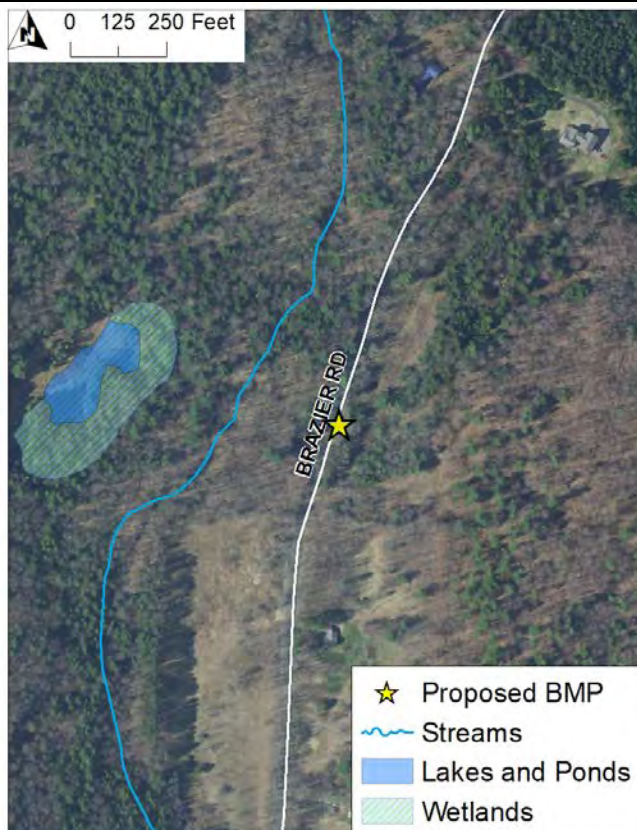
**Site map**

Areas of road are not formally ditched. Potential to add check dams and turnouts. Water is currently running down the road surface. Stabilize existing ditching.

Road with erosion issues. Adjacent to Pratt conservation area.

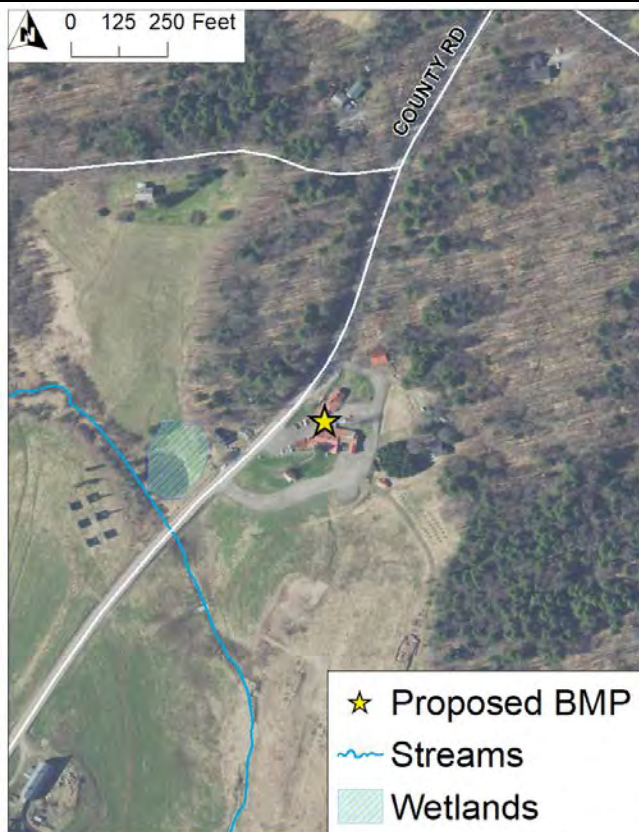
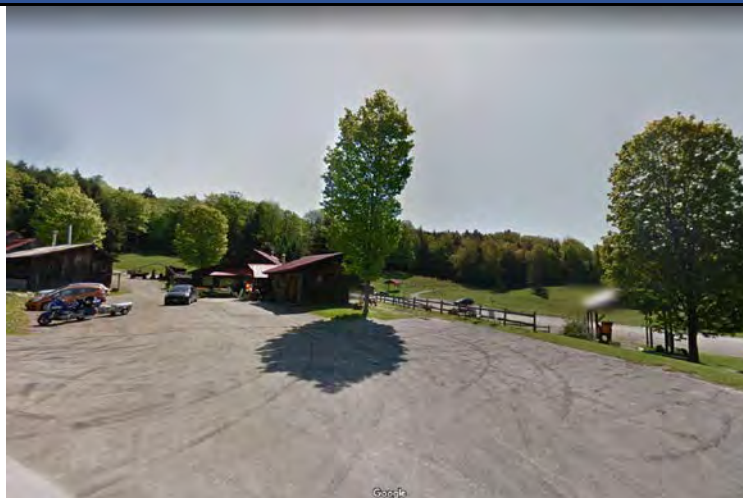
More Farm Maple Sugarworks.

Improve stream buffer that runs through field south of main site. Area is likely a water source for animals. Direct roof runoff to stormwater planters. Potential to install sand filter along County Rd.

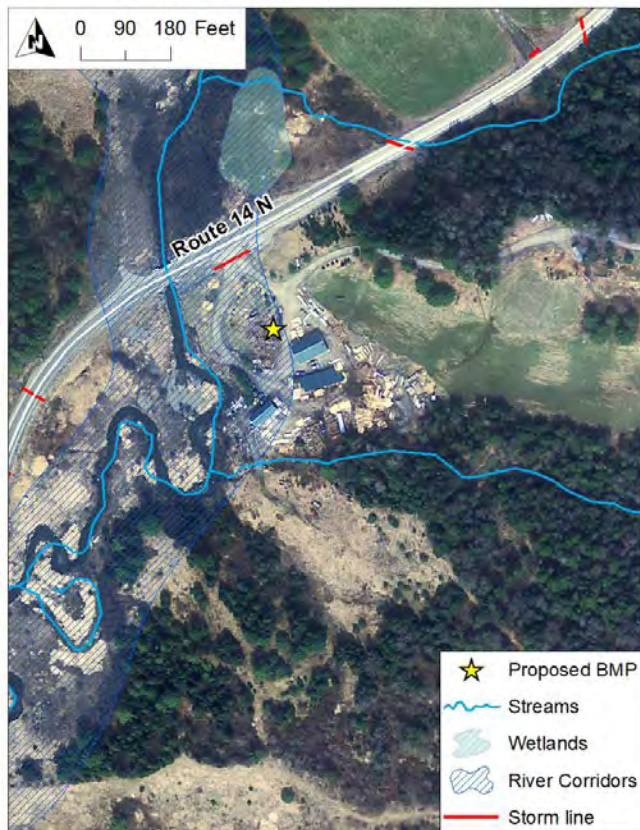
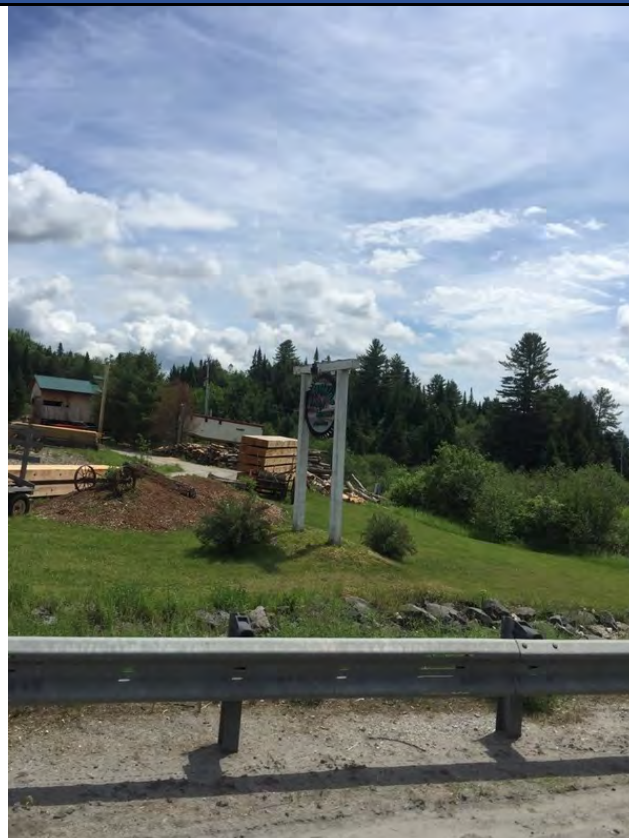
Development along river

Add vegetated buffer to river. Also, potential to infiltrate drainage prior to river on the east side of access drive (outside of river corridor), and to collect roof drainage in cisterns for water reuse.

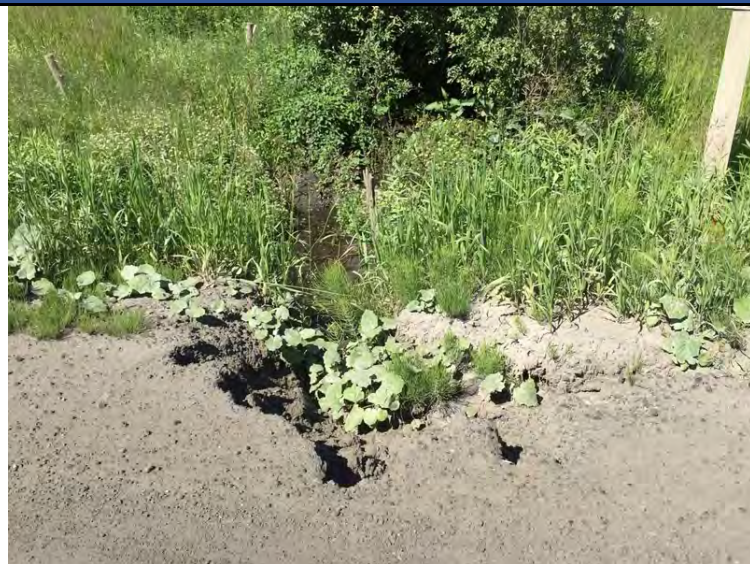
**Site photo**

Soils are sandy and prone to erosion. No active erosion in gully area was noted, but stream buffers should be improved to better stabilize area and prevent future erosion. Stabilize eroding road area by stream culvert on Lyle Young Rd..

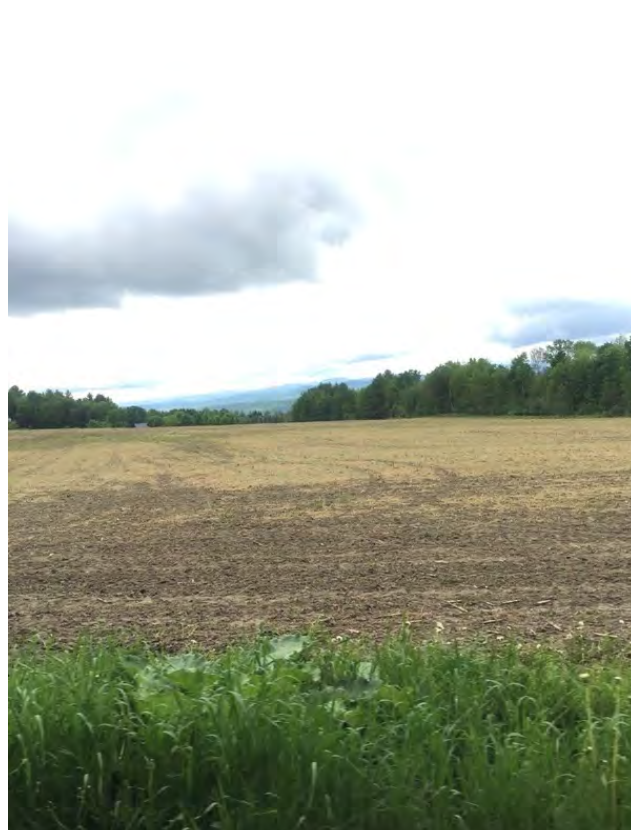
**Site photo**

**Site name:** North St Field

Add buffer along spring to filter runoff; potential to add a filter berm to intercept agricultural runoff.

Farm field at the intersection of North St and Cummings Rd.

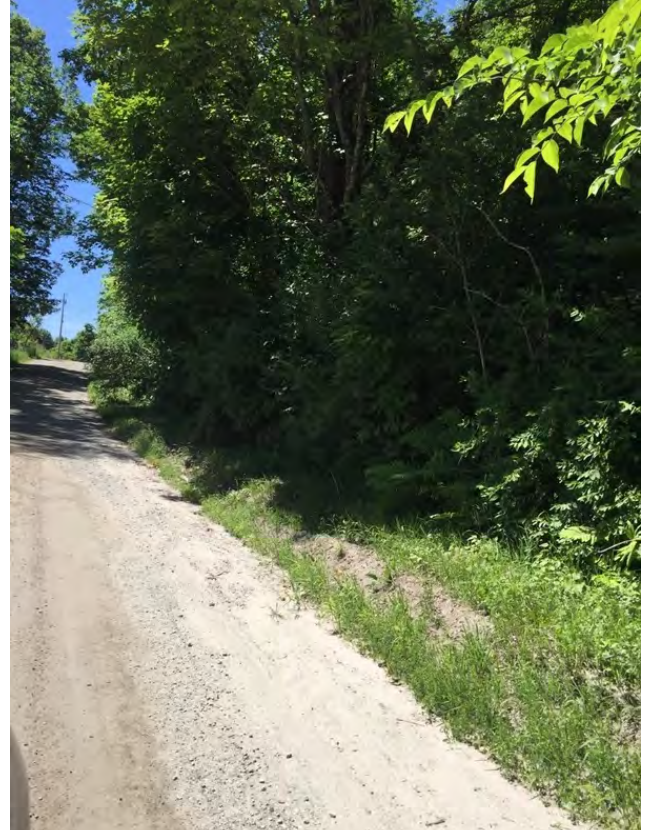
**Site photo**

**Site name:** Taylor Farm Rd

Regrade road to better direct water off road.

Road that has a small section within East Montpelier.

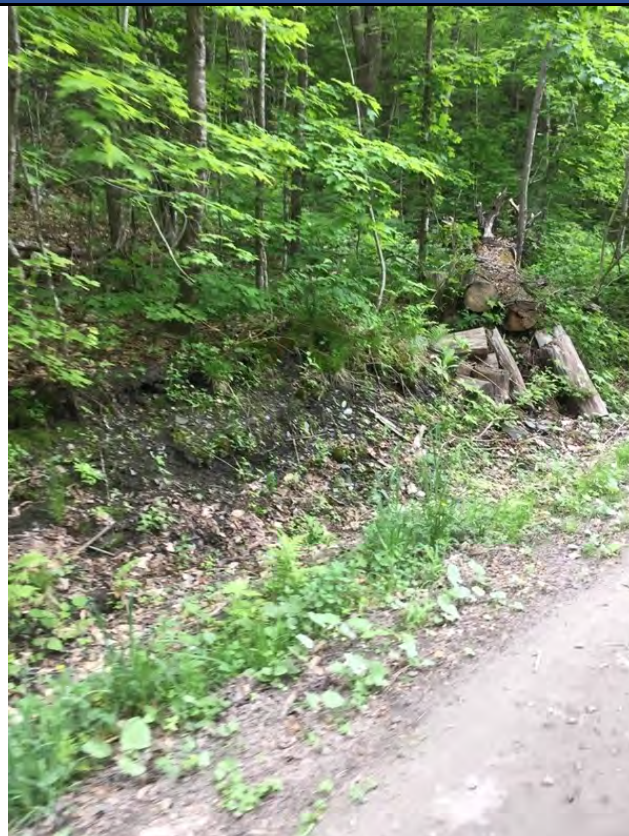
**Site photo**

**Site name:** North St

Road with some noted erosion.

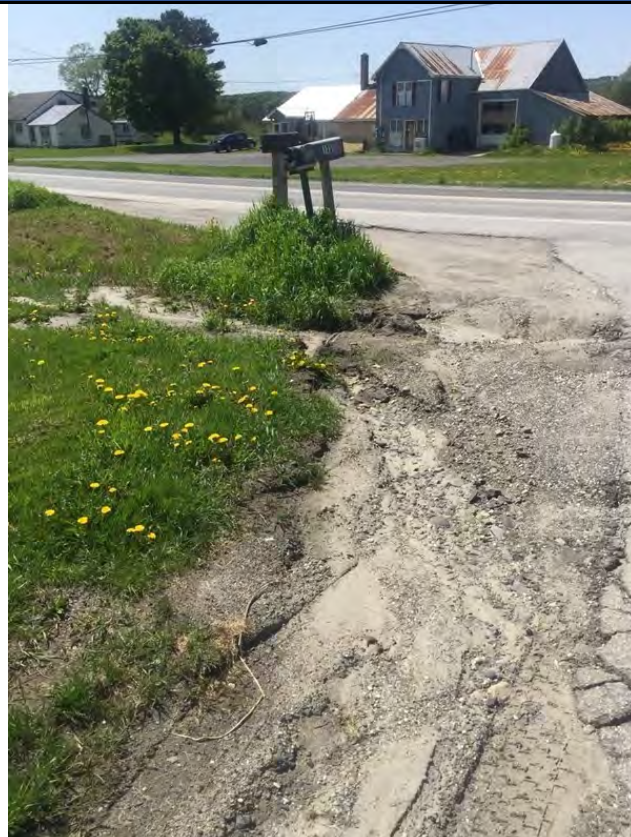
**Site photo**

**Site name:** L Brown Dr Residential

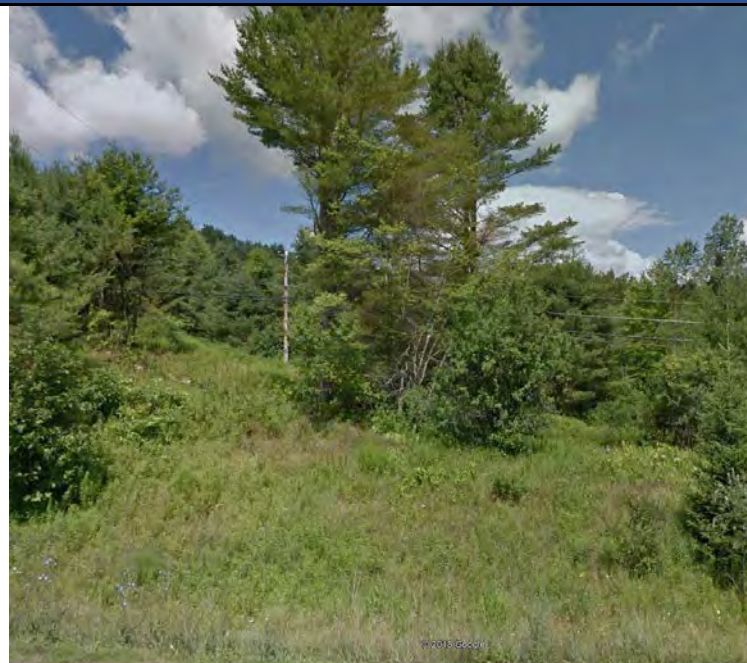
**Site photo**

Revegetate any bare areas upslope of landslide. This slide is primarily caused by topography and soil conditions, not stormwater inputs.

Landslide noted to the west of Route 2
