Upper Winooski River: Plainfield to Montpelier

River Corridor Management Plan

FINAL REPORT

MARCH 31, 2010

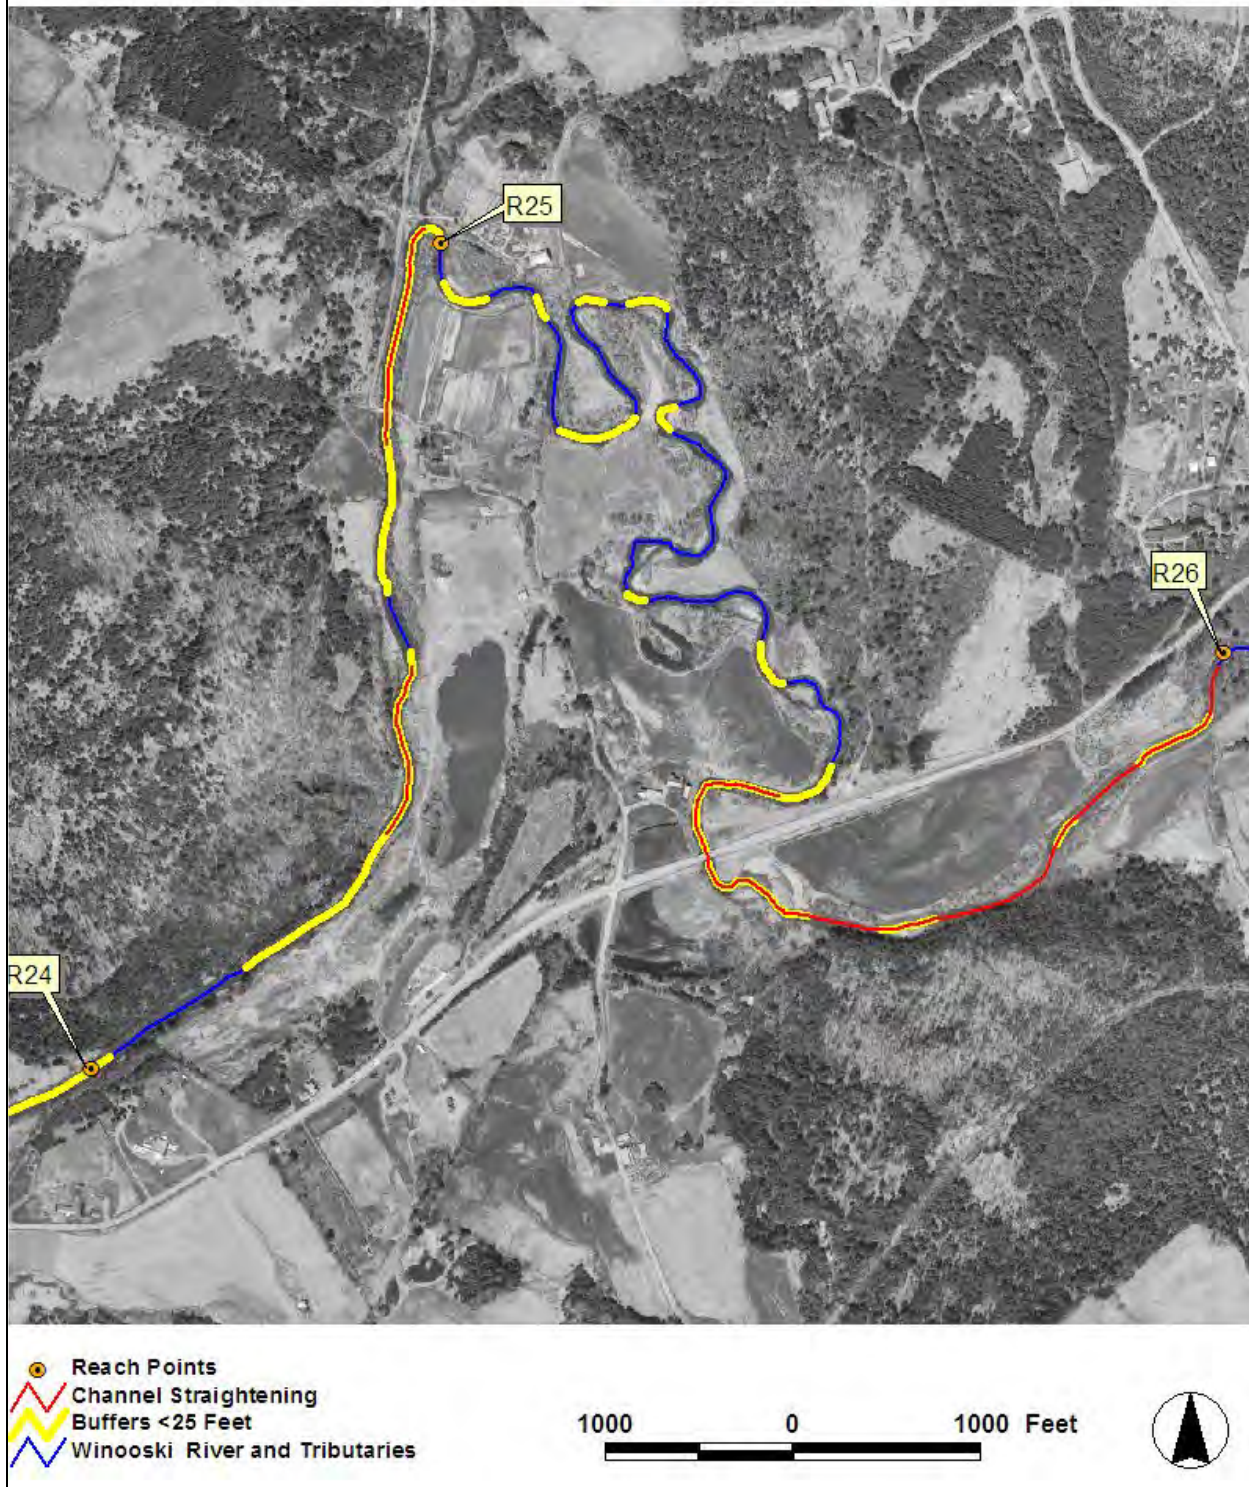
Figure 5: Reaches R25 through R24 with channel straightening and riparian buffers <25 feet wide.

Current conditions in the channel include some encroachment in the floodplain by the Coburn Road. The covered Coburn Bridge rests on narrow abutments that are causing streambank scour both upstream and downstream of the structure (this despite the bridge itself having been elevated several years ago in order to improve flood flow capacity under the structure). Streambank erosion and rip-rapping are common along much of the reach (less riprap in the more remote downstream area). The riparian buffer has been disturbed along much of the river (particularly upstream) due to agricultural activities, the road, and the mining operation. Some berming along the left bank exists at the mining operation and reduces access to a potential floodplain area.

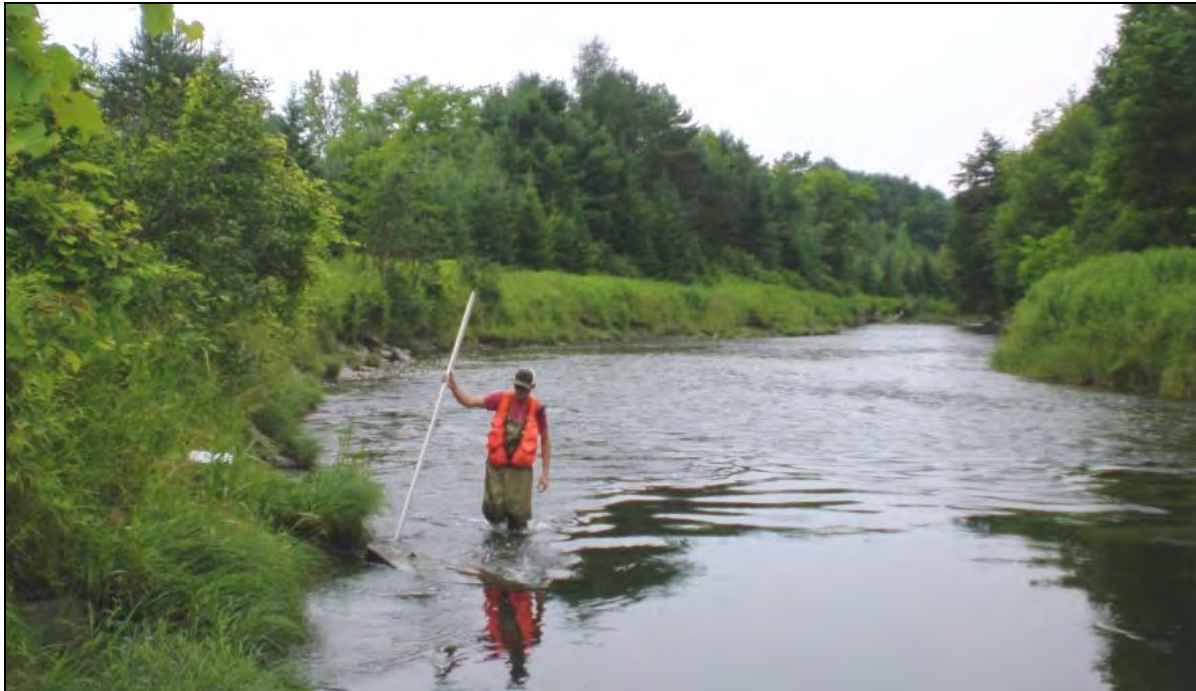
R24 is slightly incised. Excessive energy in the channel may have caused a large mass failure on the right bank as well as other intermittent erosion patches that exist commonly on both the right and left banks. It also may have reduced the habitat complexity which is dominated by a plane bed bottom and only two riffles over the course of the mile long reach (sediment contributions from R25 and the Kingsbury branch may also have filled in some of the bottom topography) (see Figure 7).

Figure 7: Measuring channel incision along reach R24.

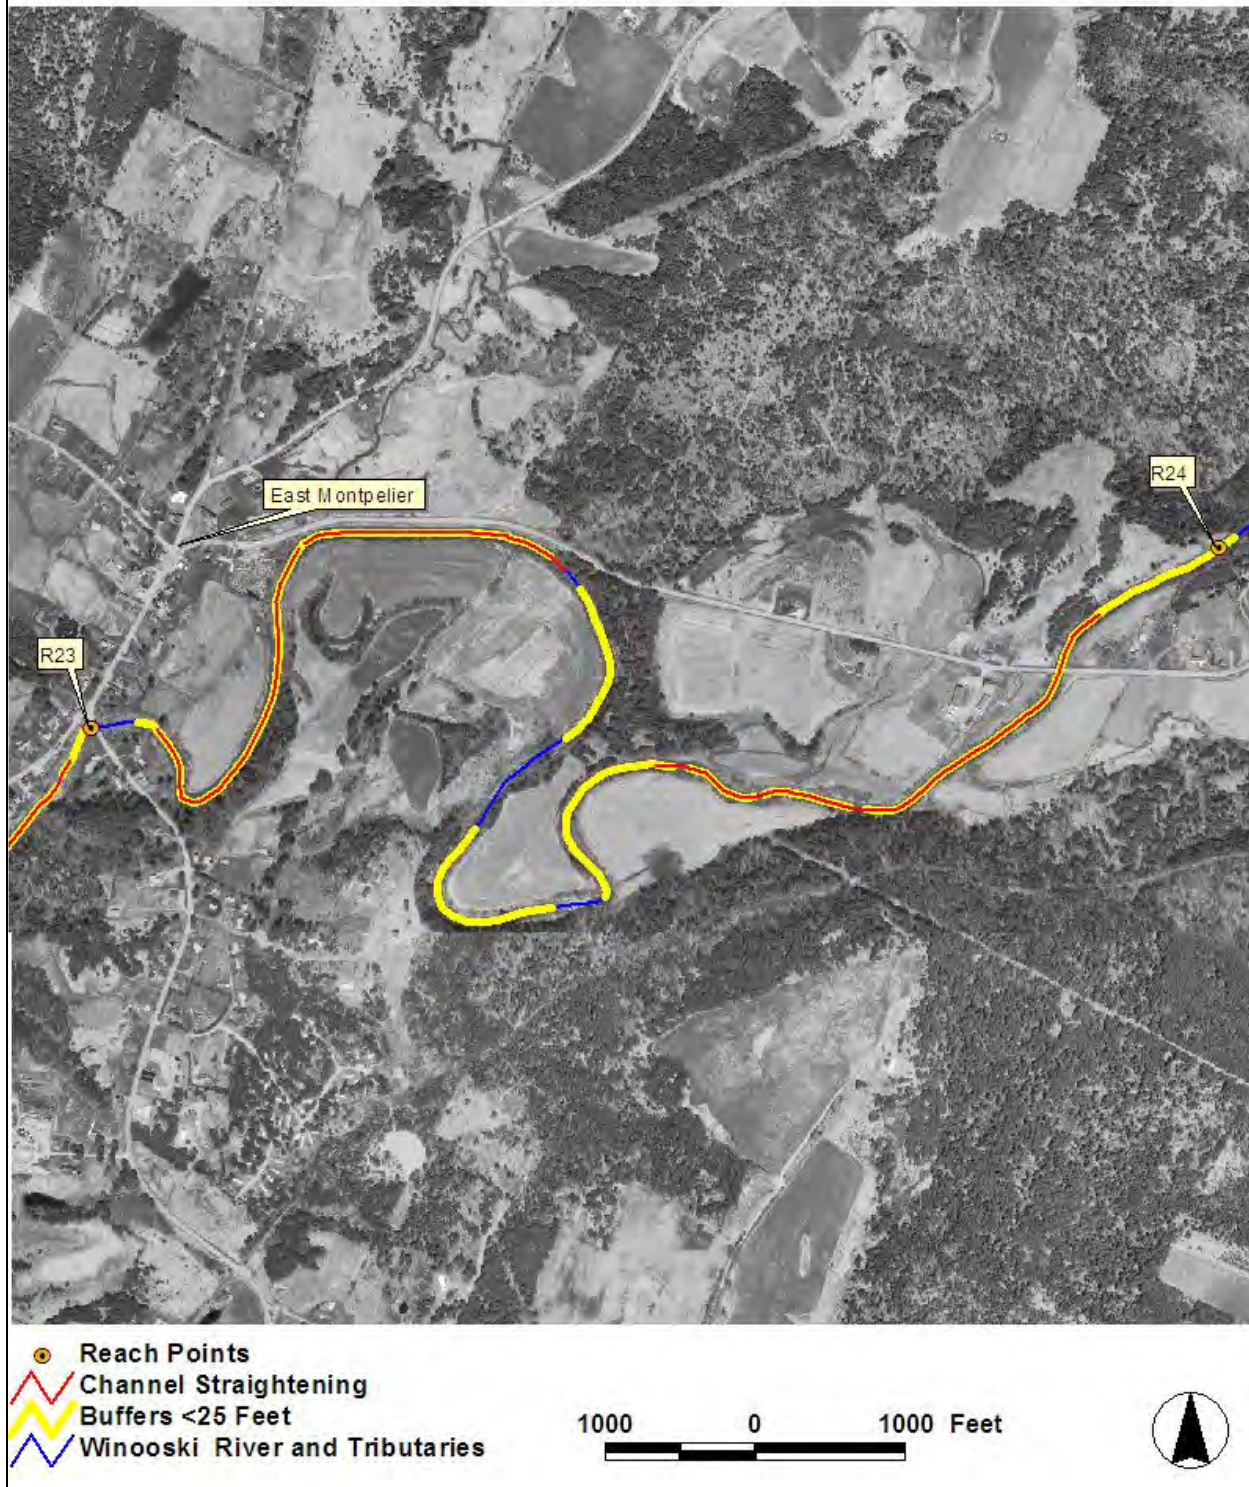
Figure 8: Reach R23 with channel straightening and riparian buffers <25 feet wide.

R23 is an “E” type channel by reference and should by nature be sinuous, narrow, and deep with excellent floodplain access. The reach is, however, severely incised. Excess erosive energy is widening the stream channel and exacerbating planform adjustment. These processes may have contributed to triggering several mass failures which are found in the lower part of the reach. Incision is so excessive that the entrenchment of the channel has been reduced and the channel is now best described as a “B” type channel having departed from reference channel conditions. As the stream widens and adjusts laterally it is already building new floodplain benches on the inside of some meander bends. These floodplain benches will colonize with vegetation and may, over time, become part of the functioning floodplain for the Winooski. The geomorphic adjustment processes are, however, causing excessive streambank erosion along much of the reach and sending these sediments downstream into other reaches reducing stream bottom habitat and transporting nutrients towards Lake Champlain.

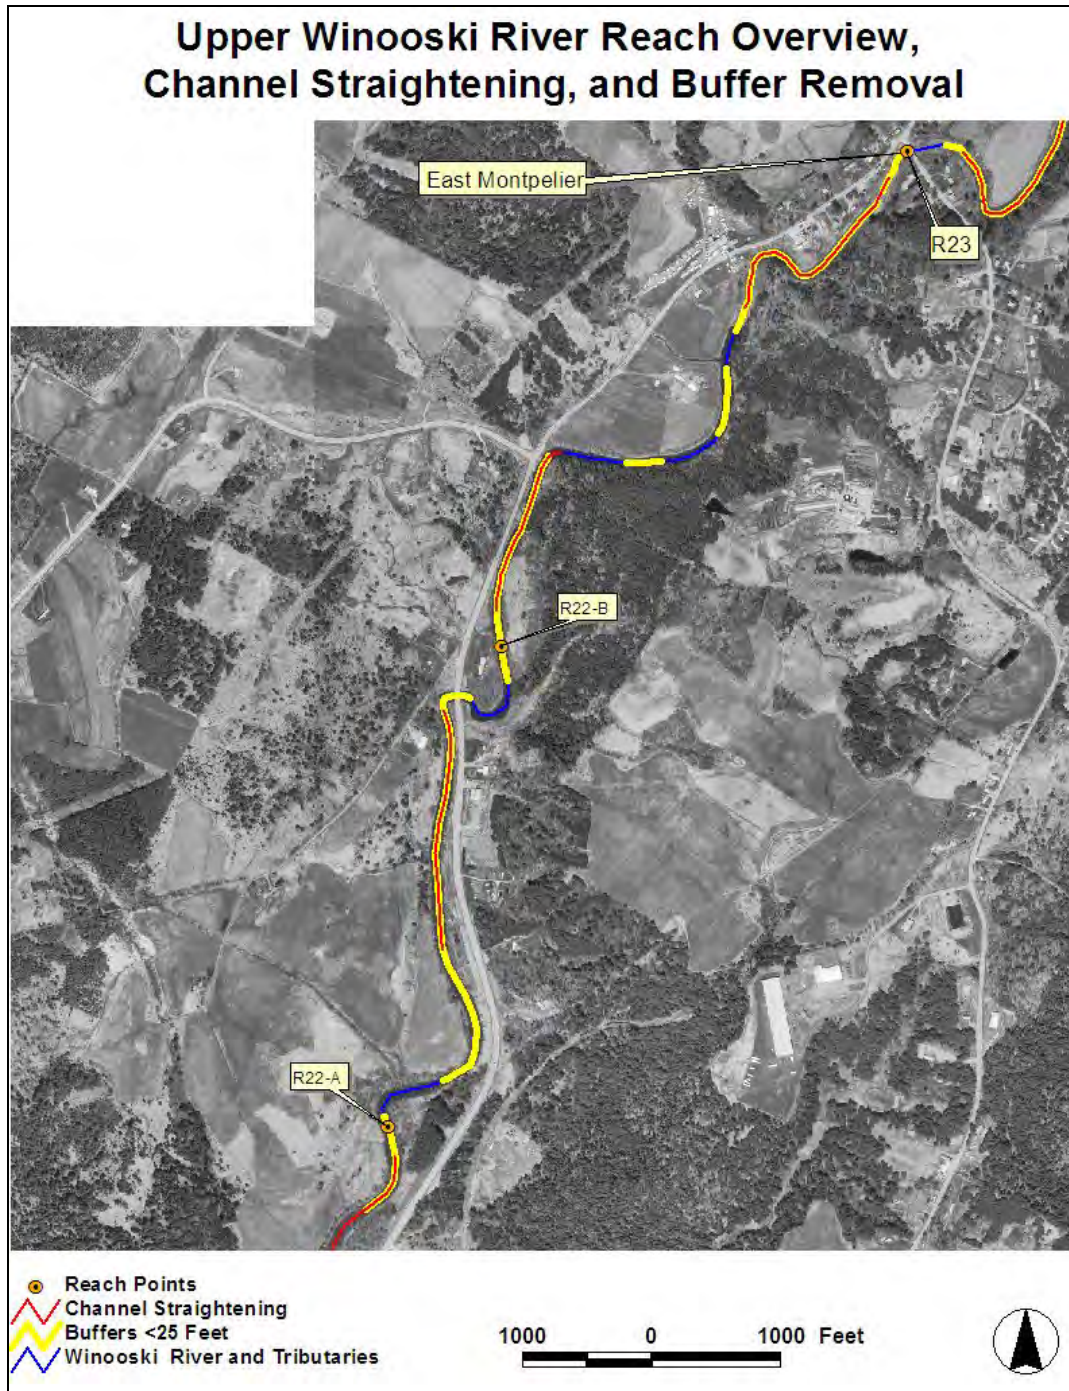
The fourth section of river (illustrated in Figure 10) begins from the Route 14 South Bridge in East Montpelier and continues downstream towards Montpelier. The valley is predominately broad and land use is dominated by forest, agriculture, residences and some commercial use. Major significant impacts in this section include: removal of riparian vegetation, channel straightening, channel armoring, and floodplain encroachment.

Figure 10: Reach R22 with channel straightening and riparian buffers <25 feet wide.

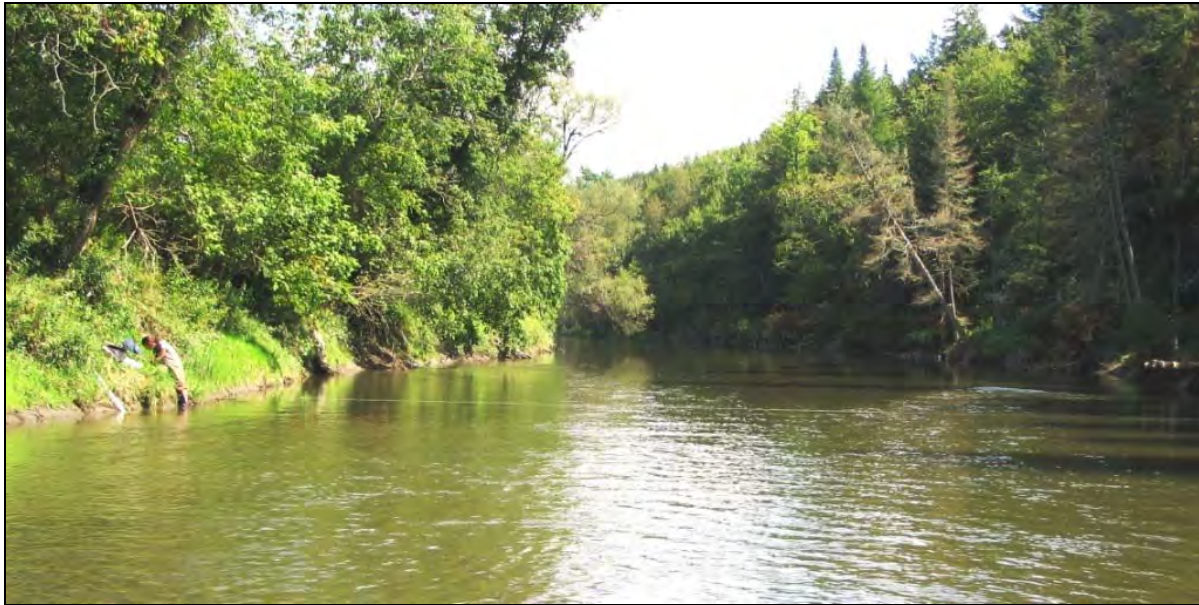
“R22B also may have also been straightened in the past because of development in East Montpelier. The geomorphic and habitat assessment scores were 0.45 and 0.43 respectively, both “fair” conditions. The segment was found to be in Stage III of evolution and has lost access to its historic floodplain. The dominant adjustment processes are widening and historic degradation. Active channel migration evidenced by flute chutes was observed. There is aggradation at the mouth of the tributary, Mallory Brook, as is evident by depositional features such as delta, side, point and mid-channel bars. The right riparian corridor was dominated by a hay field on the right, and had a narrow buffer of less than 5 feet. The left riparian corridor consisted of forest with a buffer of more than 100 feet.”

Figure 11: Cross section on reach R22-B. Photo credit: Johnson Company

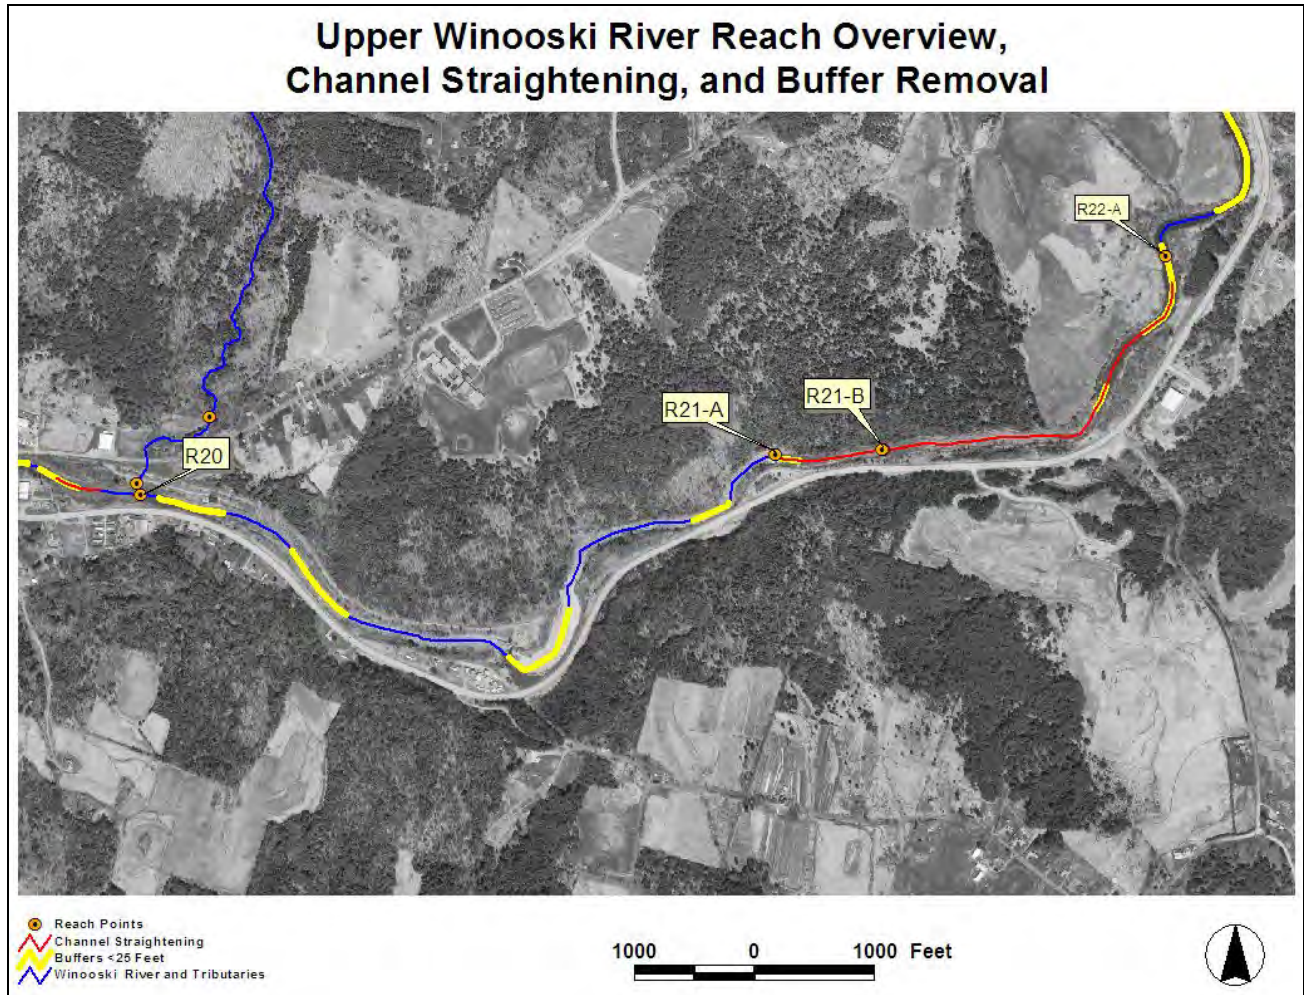
The fifth section of river (illustrated in Figure 13) begins from below the hanging bridge in East Montpelier and continues downstream towards Montpelier flowing over three dams including the near 100 year old Winooski #4 dam operated by Winooski Hydroelectric Company. The valley is predominately semi-confined and use is dominated by forest, agriculture, and commercial use. Major significant impacts in this section include: removal of riparian vegetation, channel straightening, channel armoring, two dams, and floodplain encroachment.

Figure 13: Reaches R21 and R20 with channel straightening and riparian buffers <25 feet wide.

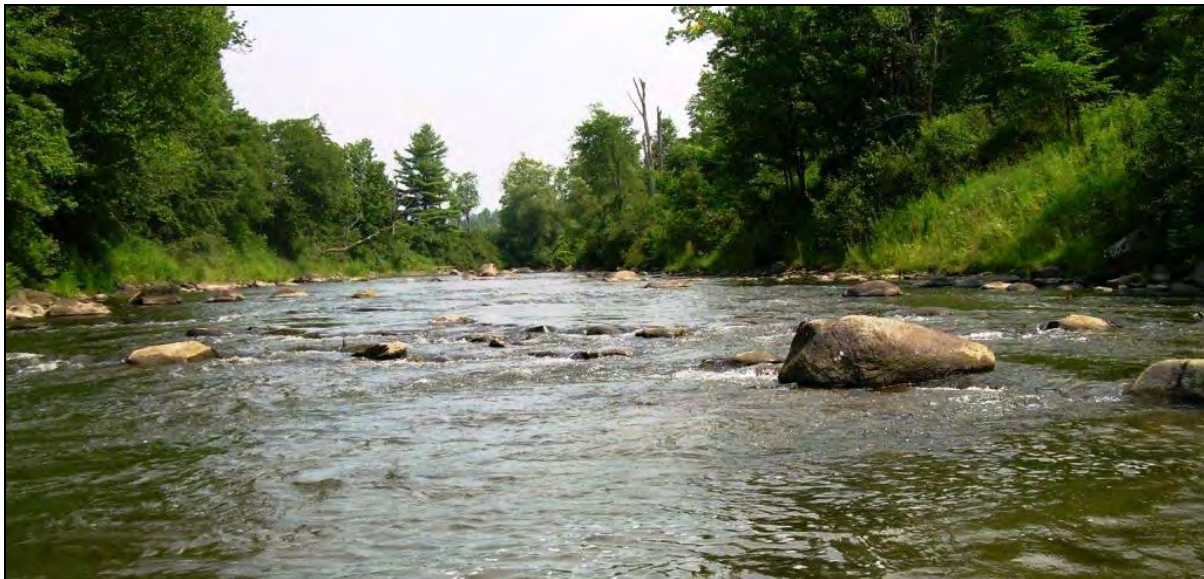
Winooski River segment R21-B begins just upstream from Packard Road in East Montpelier where the channel bends away from Route 2. The valley and channel slope of the Winooski become steeper as the valley becomes semi-confined and dominated by agriculture on the right bank and the old Route 2 corridor on the left bank. The reach is characterized by a fairly straight channel with little room to adjust laterally. There exists significant rip rap on left bank (concrete and quarried stone) that was likely put in place to protect the historic route 2 road bed. Large boulders exist in stream channel indicating the rivers greater ability to transport fine materials in this narrow, steeper reach (Figure 14). Because of this natural and enhanced (due to the old Route 2 roadbed) condition, very little sediment storage potential exists in this reach. The dominant channel adjustment processes are historic channel incision and current channel widening.

Figure 14: R21-B flows over boulders and cobbles alongside the old route 2 roadbed which flanks the left bank (right side of photo).

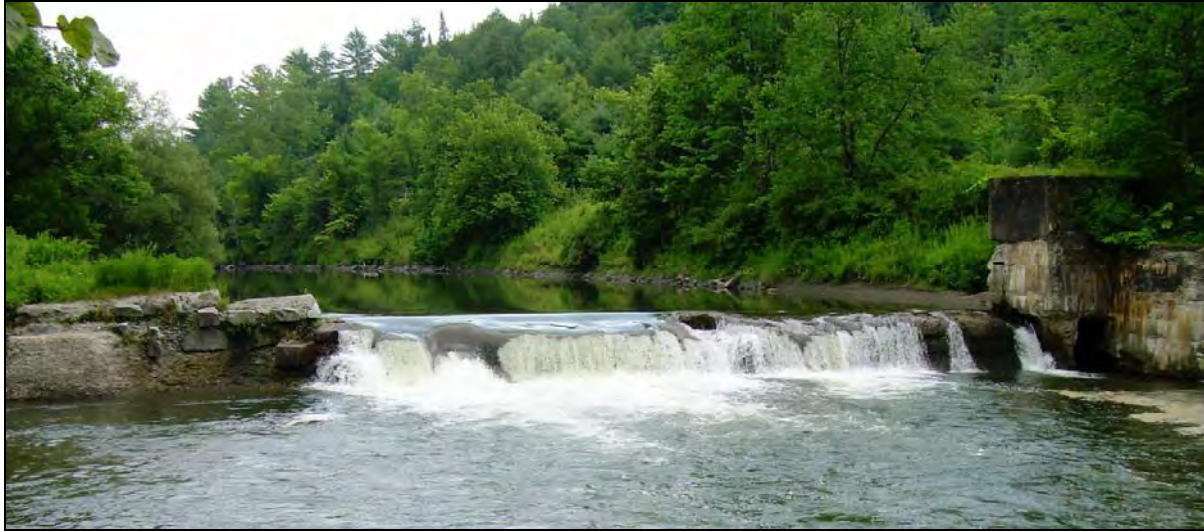
Winooski River segment R21-A was only partially assessed due to the impact of the concrete dam that exists at its lower end (Figure 15). The dam reduces water surface slope and changes the channel bottom from cobble/gravel to sand/silt. The dam is no longer in use but still impacts the channel. Just on the downstream side of the old dam a large alluvial fan has developed where a tributary affected from upstream disturbance is carrying a significant amount of sediment towards the river.

Figure 15: An old concrete dam disrupts water and sediment transport at reach R21-A (looking upstream).

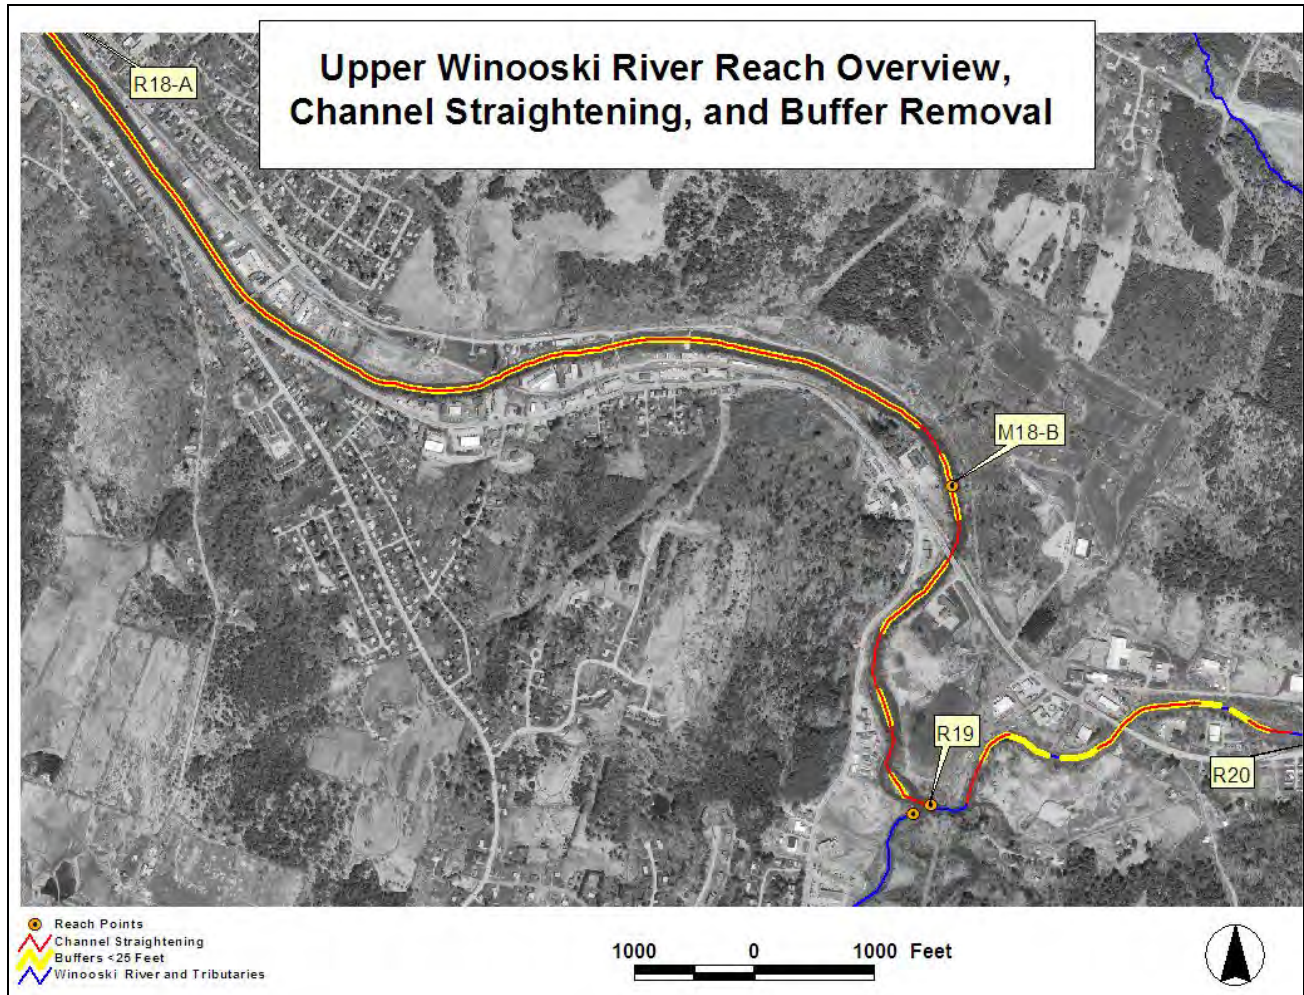
The sixth section of river (illustrated in Figure 16) begins from the confluence with an unnamed tributary downstream of the Winooski #4 dam to the confluence with the North Branch in downtown Montpelier. The valley alternates from semi-confined to broad and is dominated commercial land use. Major significant impacts in this section include: removal of riparian vegetation, channel straightening, channel armoring, two dams, and floodplain encroachment due to urban development.

Figure 16 Reaches R20, R19, and R18 with channel straightening and riparian buffers <25 feet wide.

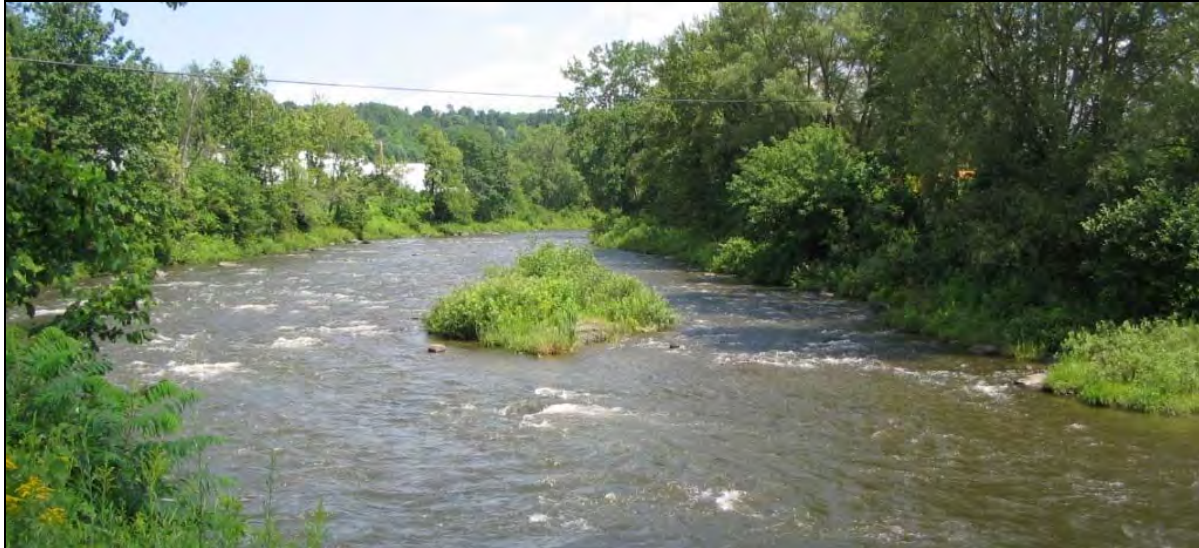
“It was found to be an F boulder stream, which was a stream type departure from the Phase 1 reference C stream type. The stream type departure is due to historic degradation and the commercial and industrial development along Route 2. These stressors have lowered the entrenchment to 1.5 and increased the incision ratio to 1.4. The major active adjustment process is widening, as evidenced by rip-rap failure of approximately 160 feet long located upstream from the railroad bridge on the left bank. The two bridges are channel constrictions. Although bank instability was clear near the two bridges, no active head cuts were documented. The reach was found to be in Stage III of evolution. Historically, the reach has been straightened. The habitat score was 0.48, or “fair,” and geomorphic score 0.34 or in “poor” condition. Relatively minor bank erosion was noted along both the right and left bank with a total length of 185 feet and an average height of 10 feet. The right bank erosion is located upstream from the bridge on Route 2 and adjacent to a parking lot. The left bank erosion is located downstream and adjacent to the

railroad bridge. The erosion is related to constriction by the bridge. The riparian corridor was dominated by development. Buffers ranged from <5 to 25 feet along the left and <5 feet along the right. This reach may be affected by the water release coming from the Levesque Station-Montpelier Hydroelectric Dam #4. The lower portion of the reach is connected to the mouth of the Steven Branch and the Food Works site described above.”

Figure 17: Typical channel conditions along reach R19. Photo credit: Johnson Company

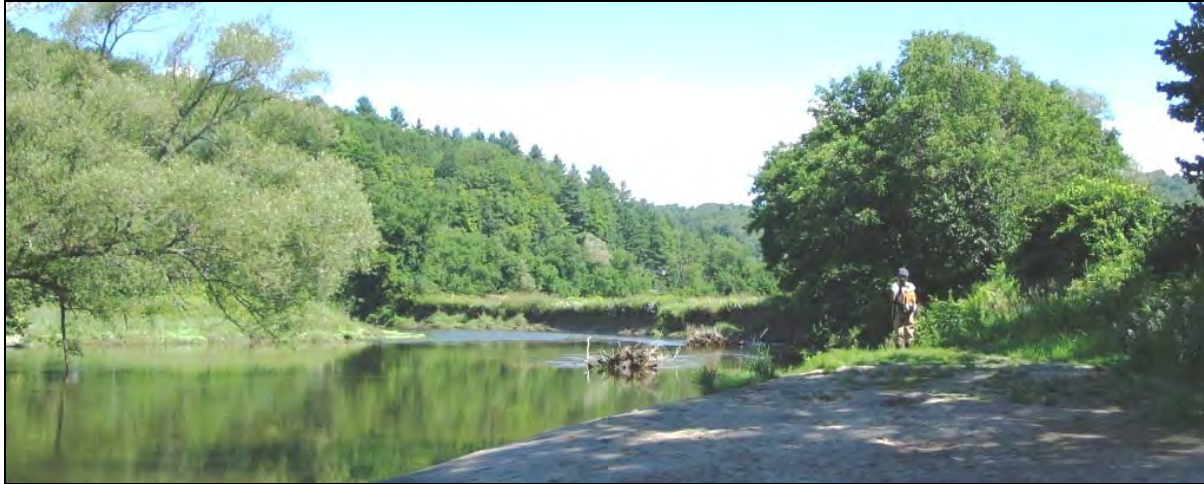
“R18-B may have also been straightened in the past. The geomorphic and habitat assessment scores were 0.33 and 0.34 respectively, both “poor” conditions. The dominant adjustment process was [historic] degradation and widening (see Figure 18), with an incision ratio of 1.9 and enrichment ratio of 1.6. The segment was found to be in Stage III of evolution and has lost access to its historic floodplain. Evidence of channel avulsion was found on the upper portion of the segment near the confluence with the Stevens Branch. The right riparian corridor was dominated by agricultural crops managed by the Food Works project, and had a buffer from 5-25 feet. An eroding bank approximately 10 feet high and 320 feet long exists on this property. The left riparian corridor consisted of a narrow wooded buffer of <5 to 25 feet. A mobile home sales business is located on the top of the left bank. A river meander is cutting the bottom of the left bank creating some serious instability on the steep slope of the bank.”

Figure 18: Typical channel conditions along reach R18-B. Photo credit: Johnson Company

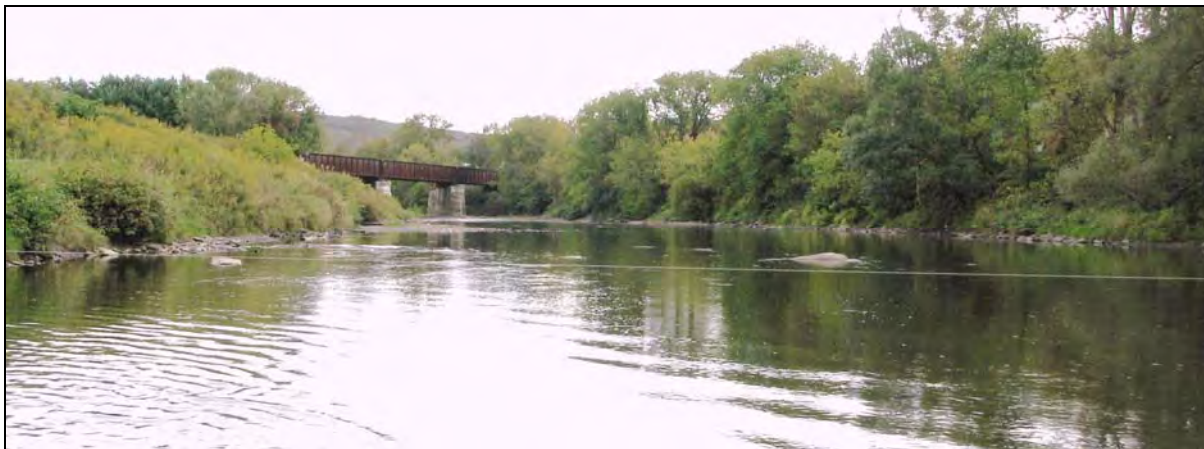
“R18-A had undergone a stream type departure from its reference C type stream to the current F type due to historic degradation and the development of Montpelier within the historic river corridor, which has lowered the entrenchment to 1.2 and increased the incision ratio to 1.5. The actual conditions show a highly entrenched stream with a moderate incision ratio (Figure 19). The segment no longer has access to its original floodplain and was found to be in evolution stage II. Historically, it has been channelized as a flood control measure for the City of Montpelier. R18A had a habitat score of 0.44 “fair” and a geomorphic assessment score of 0.30 “poor”. Despite the incision, there was relatively no erosion noted in the segment due to the significant amount of rip-rap. The riparian corridor was dominated by commercial development on both sides with a very narrow buffer of < 5 feet on both sides. An old dam located at the upper portion of the segment on a bedrock constriction serves as a grade control. The dam was found to be partially breached and does not impound much more water than the naturally occurring bedrock grade control upon which it is constructed.”

Figure 19: Typical channel conditions along reach R18-A. Photo credit: Johnson Company

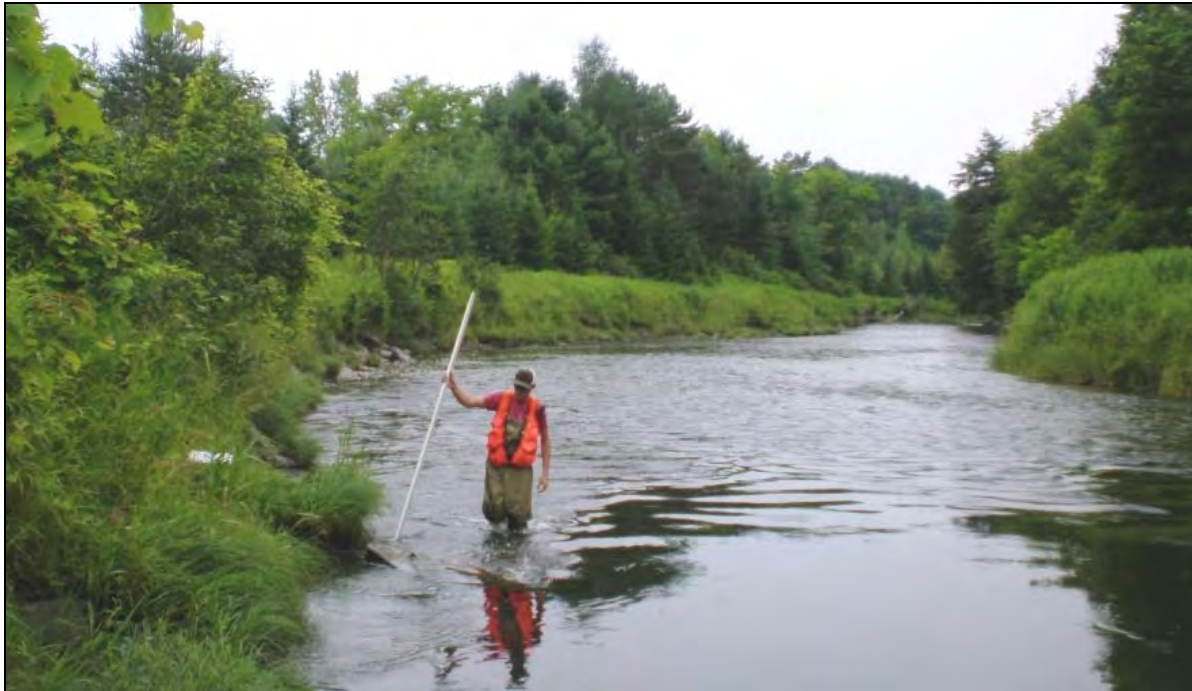
R24 is slightly incised. Excessive energy in the channel may have caused a large mass failure on the right bank as well as other intermittent erosion patches that exist commonly on both the right and left banks. It also may have reduced the habitat complexity which is dominated by a plane bed bottom and only two riffles over the course of the mile long reach (sediment contributions from R25 and the Kingsbury branch may also have filled in some of the bottom topography) (see Figure 7).

Figure 7: Measuring channel incision along reach R24.

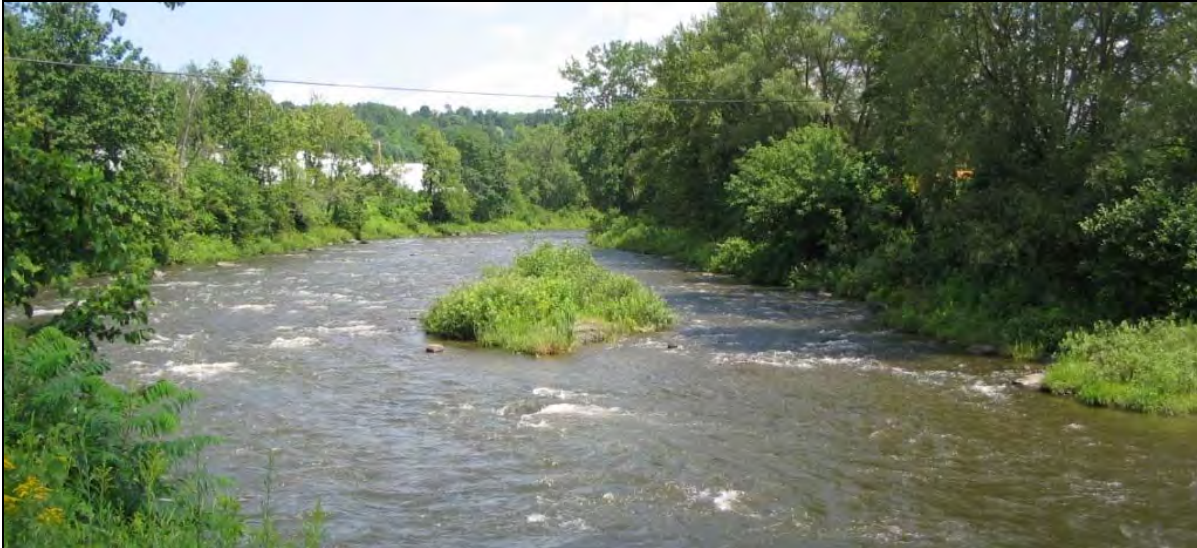
railroad bridge. The erosion is related to constriction by the bridge. The riparian corridor was dominated by development. Buffers ranged from <5 to 25 feet along the left and <5 feet along the right. This reach may be affected by the water release coming from the Levesque Station-Montpelier Hydroelectric Dam #4. The lower portion of the reach is connected to the mouth of the Steven Branch and the Food Works site described above.”

Figure 17: Typical channel conditions along reach R19. Photo credit: Johnson Company

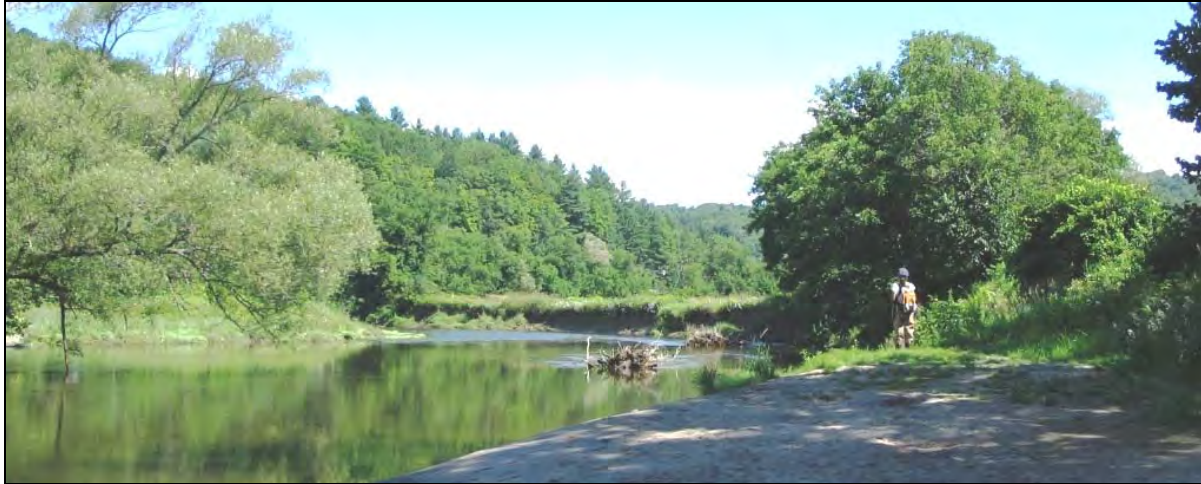
“R18-B may have also been straightened in the past. The geomorphic and habitat assessment scores were 0.33 and 0.34 respectively, both “poor” conditions. The dominant adjustment process was [historic] degradation and widening (see Figure 18), with an incision ratio of 1.9 and enrichment ratio of 1.6. The segment was found to be in Stage III of evolution and has lost access to its historic floodplain. Evidence of channel avulsion was found on the upper portion of the segment near the confluence with the Stevens Branch. The right riparian corridor was dominated by agricultural crops managed by the Food Works project, and had a buffer from 5-25 feet. An eroding bank approximately 10 feet high and 320 feet long exists on this property. The left riparian corridor consisted of a narrow wooded buffer of <5 to 25 feet. A mobile home sales business is located on the top of the left bank. A river meander is cutting the bottom of the left bank creating some serious instability on the steep slope of the bank.”

Figure 18: Typical channel conditions along reach R18-B. Photo credit: Johnson Company

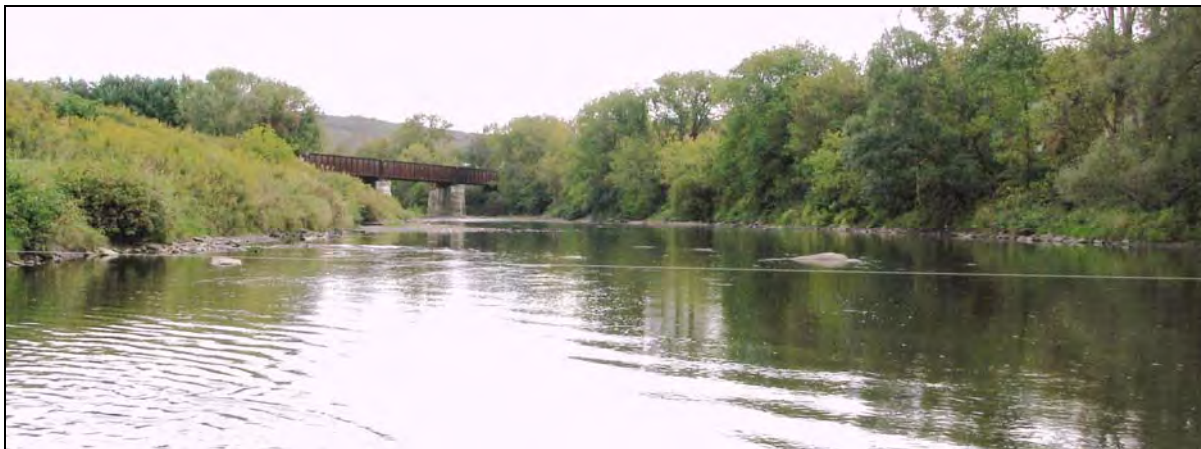
“R18-A had undergone a stream type departure from its reference C type stream to the current F type due to historic degradation and the development of Montpelier within the historic river corridor, which has lowered the entrenchment to 1.2 and increased the incision ratio to 1.5. The actual conditions show a highly entrenched stream with a moderate incision ratio (Figure 19). The segment no longer has access to its original floodplain and was found to be in evolution stage II. Historically, it has been channelized as a flood control measure for the City of Montpelier. R18A had a habitat score of 0.44 “fair” and a geomorphic assessment score of 0.30 “poor”. Despite the incision, there was relatively no erosion noted in the segment due to the significant amount of rip-rap. The riparian corridor was dominated by commercial development on both sides with a very narrow buffer of < 5 feet on both sides. An old dam located at the upper portion of the segment on a bedrock constriction serves as a grade control. The dam was found to be partially breached and does not impound much more water than the naturally occurring bedrock grade control upon which it is constructed.”

Figure 19: Typical channel conditions along reach R18-A. Photo credit: Johnson Company
